TOWN OF GAWLER

HISTORIC WALLS IN THE PUBLIC ENVIRONMENT, GAWLER, SA CONSERVATION STRATEGY

September 2007

McDougall & Vines, Conservation and Heritage Consultants
27 Sydenham Road, Norwood, South Australia 5067
Ph (08) 8362 6399 Fax (08) 8363 0121
Email: mcdvines@bigpond.com

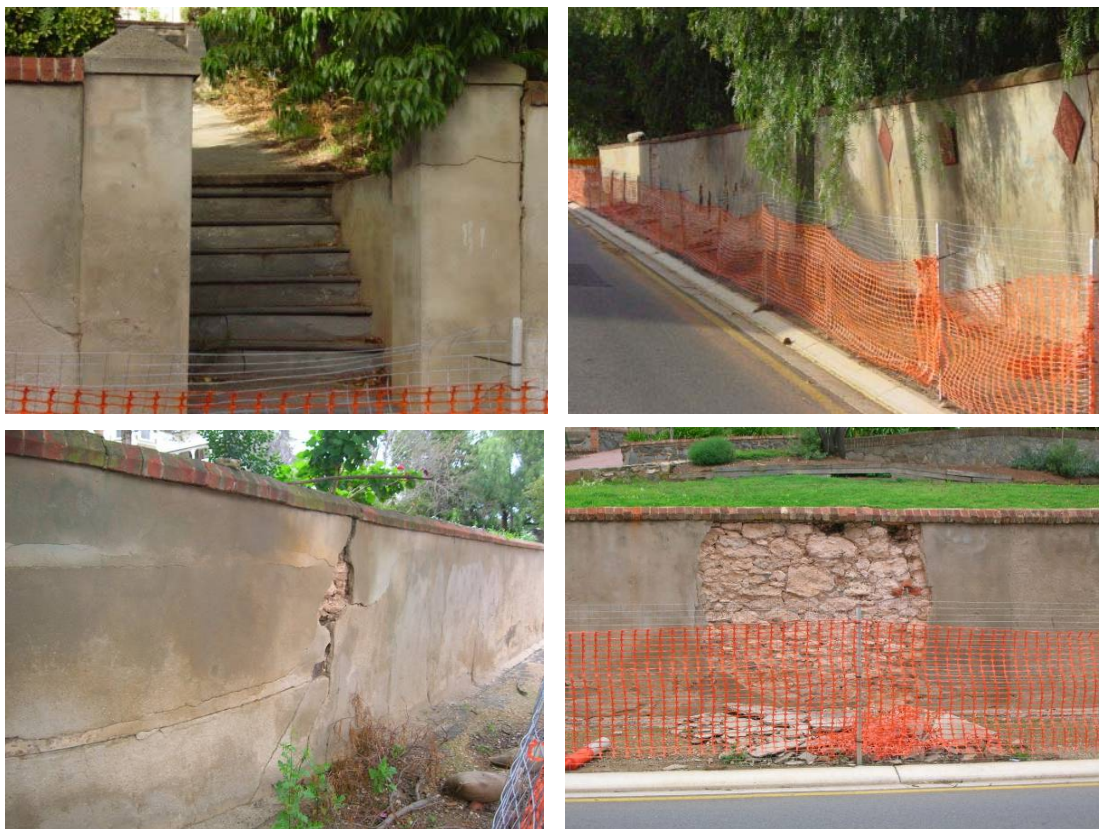
Address: 25 High Street, Gawler East **Heritage Status:** Local Heritage Place in the Town Centre Historic (Conservation) Zone, Town Centre Historic (Conservation) Policy Area

Description: This wall, approximately 42 metres long and about 2 metres high, functions as a retaining wall for the front garden. The wall is constructed of paddock limestone. The wall is topped with cant bricks on the front and the southern boundary stone wall has glass set into the rubble capping (this appears to be original).

The wall has been rendered at a later date, possibly in the 1950s, as evidenced by the pebble dash content of the render. The render is in very poor condition and in some areas has been dislodged. Structurally the wall is in poor condition with the wall leaning out towards the pavement. Towards the southern end of the wall, steel bracing rods have been inserted into the wall and are braced back into the garden. There are two large trees located in the garden bed behind the retaining wall which are contributing towards the destabilisation of the wall. Separate to this report an engineers report was prepared on this wall and the Town of Gawler provided with a copy of this report. **This report recommends either the rebuilding or the conservation of the wall as follows:**

- **Remove soil behind wall** - The first approach in the remedial works is to take the pressure off the retaining wall. It is recommended that the soil is removed to a height of approximately one metre above the base of the wall and cut back to a natural batter to meet the existing ground line of the lawn.
- **Install base wall drainage** - At the base of the wall an agricultural pipe should be provided, draining to the street. The trench should be backfilled with rubble, lined with a damp proof course ("Forticon" or similar). A terracotta or brick dish drain should be installed at the new ground level to drain away any surface water. Once the soil has been removed it will be possible to stabilise the wall using a hydraulic ram with brackets installed every 1.2 to 1.8 metres. The wall may have incorporated drainage vents similar to that at 35 High Street.

- **Removal of cement render** - Following stabilisation of the wall, the render should be carefully removed, taking off small areas at a time and working away from the most damaged portions of the wall. The cant bricks (bricks with sloping top faces) should remain in place. Where stonework has been lost, new stone should be matching limestone (or "paddock stone") installed in the wall in a similar manner. The original lime mortar mix should be matched, with a mix of 2 parts sand to 1 part lime putty with appropriate sands used to match the colour of the original mortar.

- **Assessment of tree damage** - The trees in close proximity to the wall should be assessed by an arborist. It is recommended that the trees, if not significant are removed. If they are significant trees then root growth should be contained and roots pruned.

- **Top of wall** - Remnants of a mortar capping are evident on the wall. The side boundary wall retains most of this capping. The rubble protects the brick joints and it is recommended that this is reinstated. On the side boundary wall ground glass which has been set into the rubble capping is likely to be original to the wall.

- **Steel strap strengthening** - A steel strap has been fixed to the curved portion of wall alongside the driveway to strengthen the wall. This should remain in place.

- **Repair and replacement of brick capping** - Where the brick capping is in poor condition, bricks should be re-bedded and/or replaced as necessary.

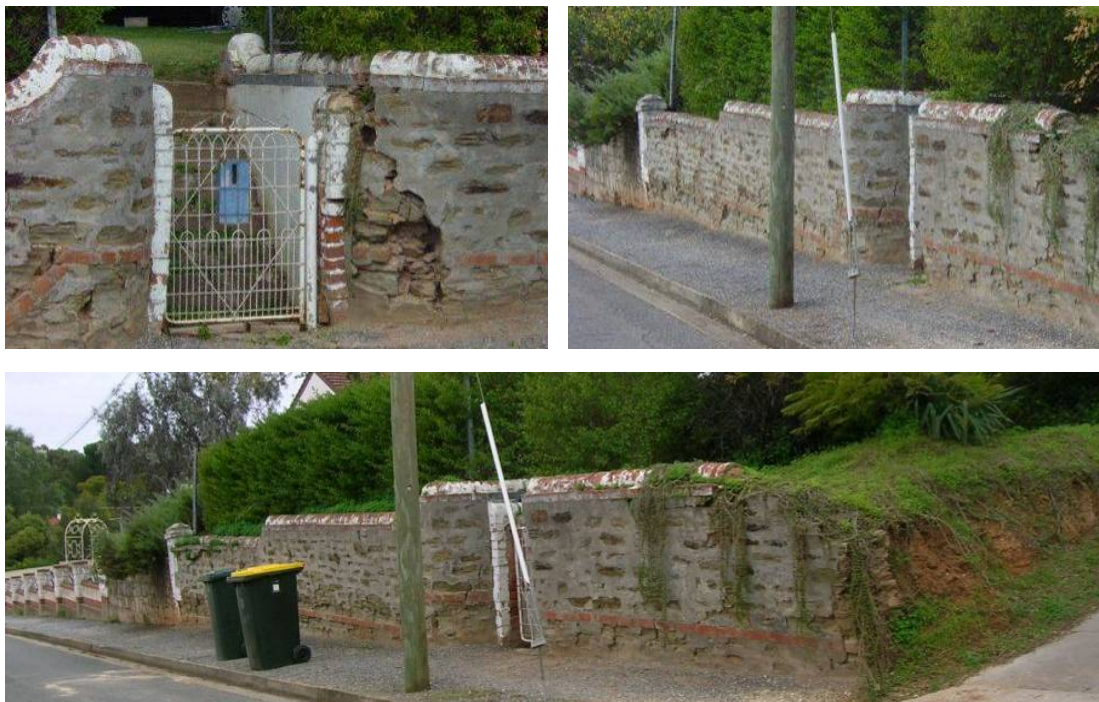
Address: 9 Daly Street, Gawler East

Description: A stepped stone wall with brick capping and brick coursing through the base of the wall. The wall incorporates a curved recess to the entrance gate which has a crimped wire gate. The wall shows typical signs of stress associated with a wall acting as a retaining wall. Brickwork and stone sections are in deteriorated condition but the wall is capable of restoration and rebuilding. The wall at the southern end has lost its corner (shown on the right hand side of the photo above)

- **Remove soil behind wall** - The first approach in the remedial works is to take the pressure off the retaining wall. It is recommended that the soil is removed to a height of approximately one metre above the base of the wall and cut back to a natural batter to meet the existing ground line of the lawn.

- **Top of wall** – The top of the wall is red painted bricks – these should be stripped of paint, and bricks should be re-bedded and/or replaced as necessary

- **Rebuilding of wall around gate entry and end of wall** - The deteriorated section of wall needs to be rebuilt using matching stone, and carefully repointed to match pointing elsewhere. The end of the wall also needs to be rebuilt.

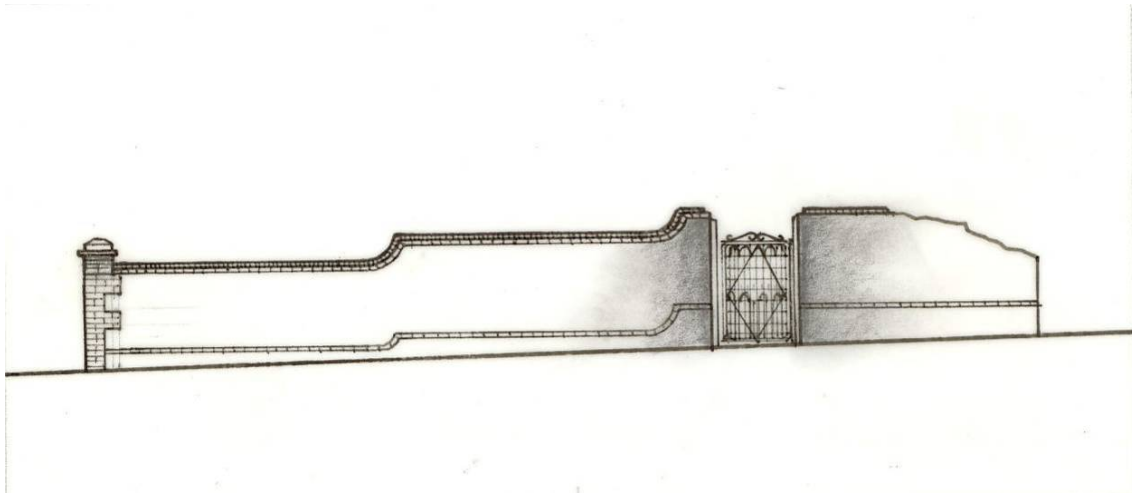
Length of wall – 13.5 m **Height of wall** – 1400 – 2300 (varies with slope of the wall) (note that the right hand end of the wall has deteriorated)

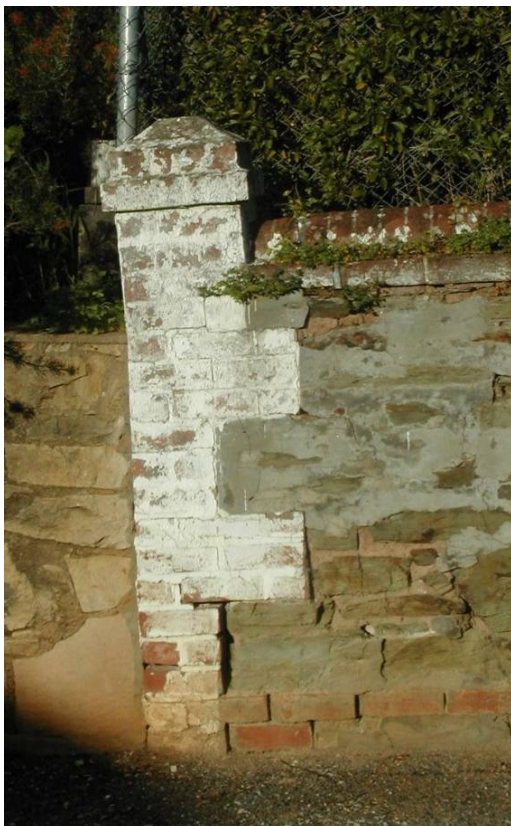
Left hand brick pier – leaning at the top.

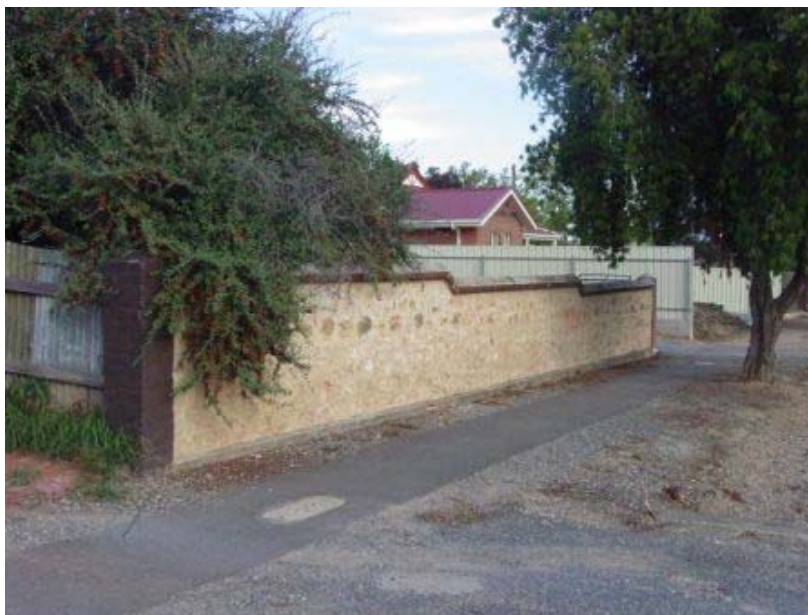
Address: 59 Main North Road, Willaston
Development Plan.

Description: A sandstone wall, which has a sloped top constructed in bricks which steps down the slope of the wall. The wall sits on a projecting brick plinth and has brick piers at either end. Structurally the wall is in good condition.

- Removal of paint off the brick piers Once paint has been removed, re-point any brick joints with lime mortar as required. Replace any bricks which may be damaged or deteriorated.
- Plinth of wall - this has been rendered over in cement, but does not at this stage appear to be causing any problems to the wall.
- Removal of later cement pointing - any cement re-pointing within the wall should be carefully removed and replaced with mortar to match the original lime mortar in colour and in texture.

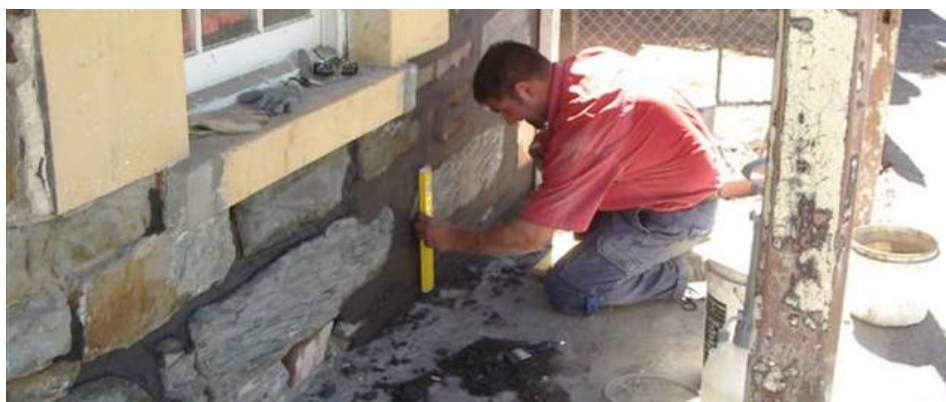
Repointing being undertaken in the base of a house wall

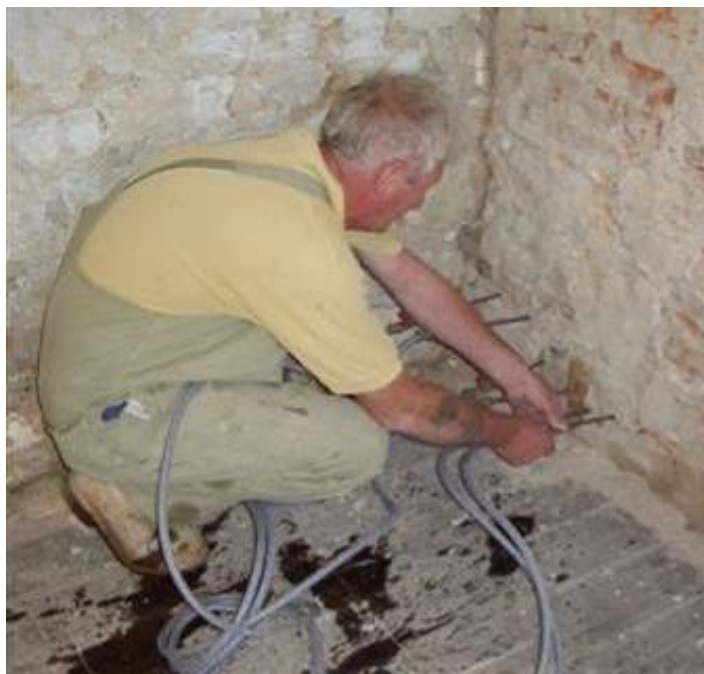
Chemical injection being undertaken via a series of tubes with siloxane fluid poured into the holes

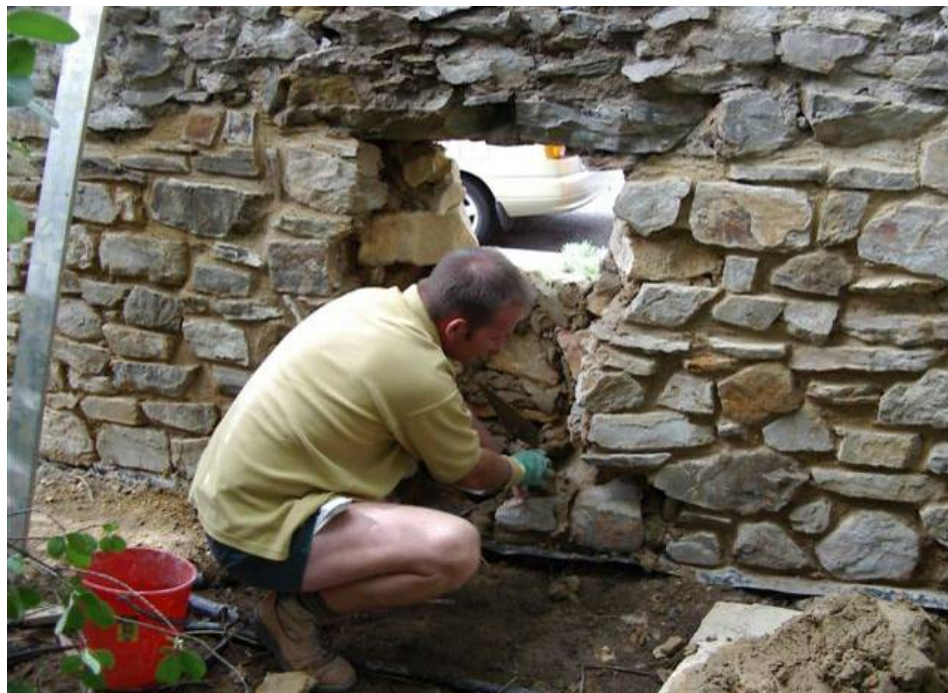
Stone replacement – note Damp Proof Course (DPC) at the base and size of hole where stone is being replaced.

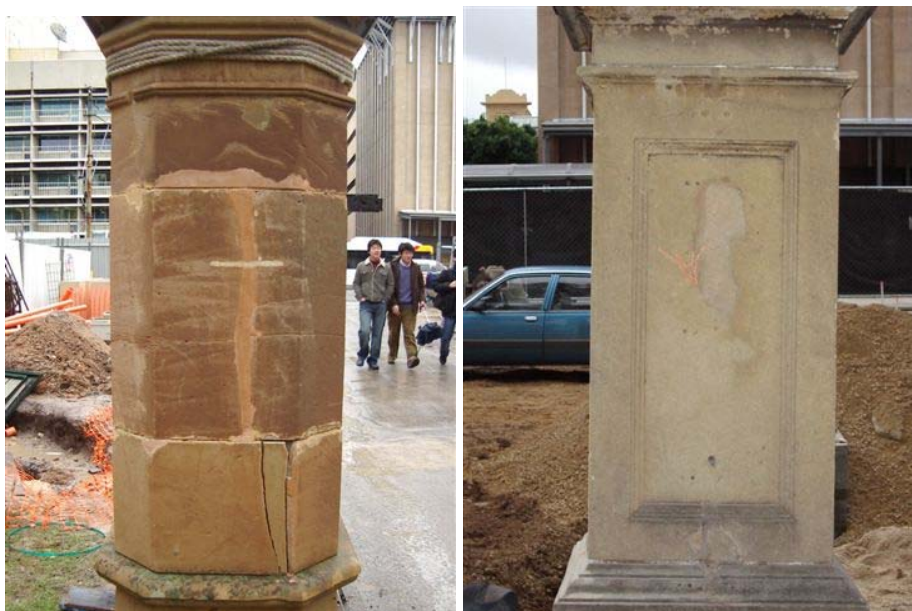
Examples of plastic repairs on fence posts
