Levee Bank Discussion Paper

Town of Gawler

May 2018

Gawler Stormwater Management Study

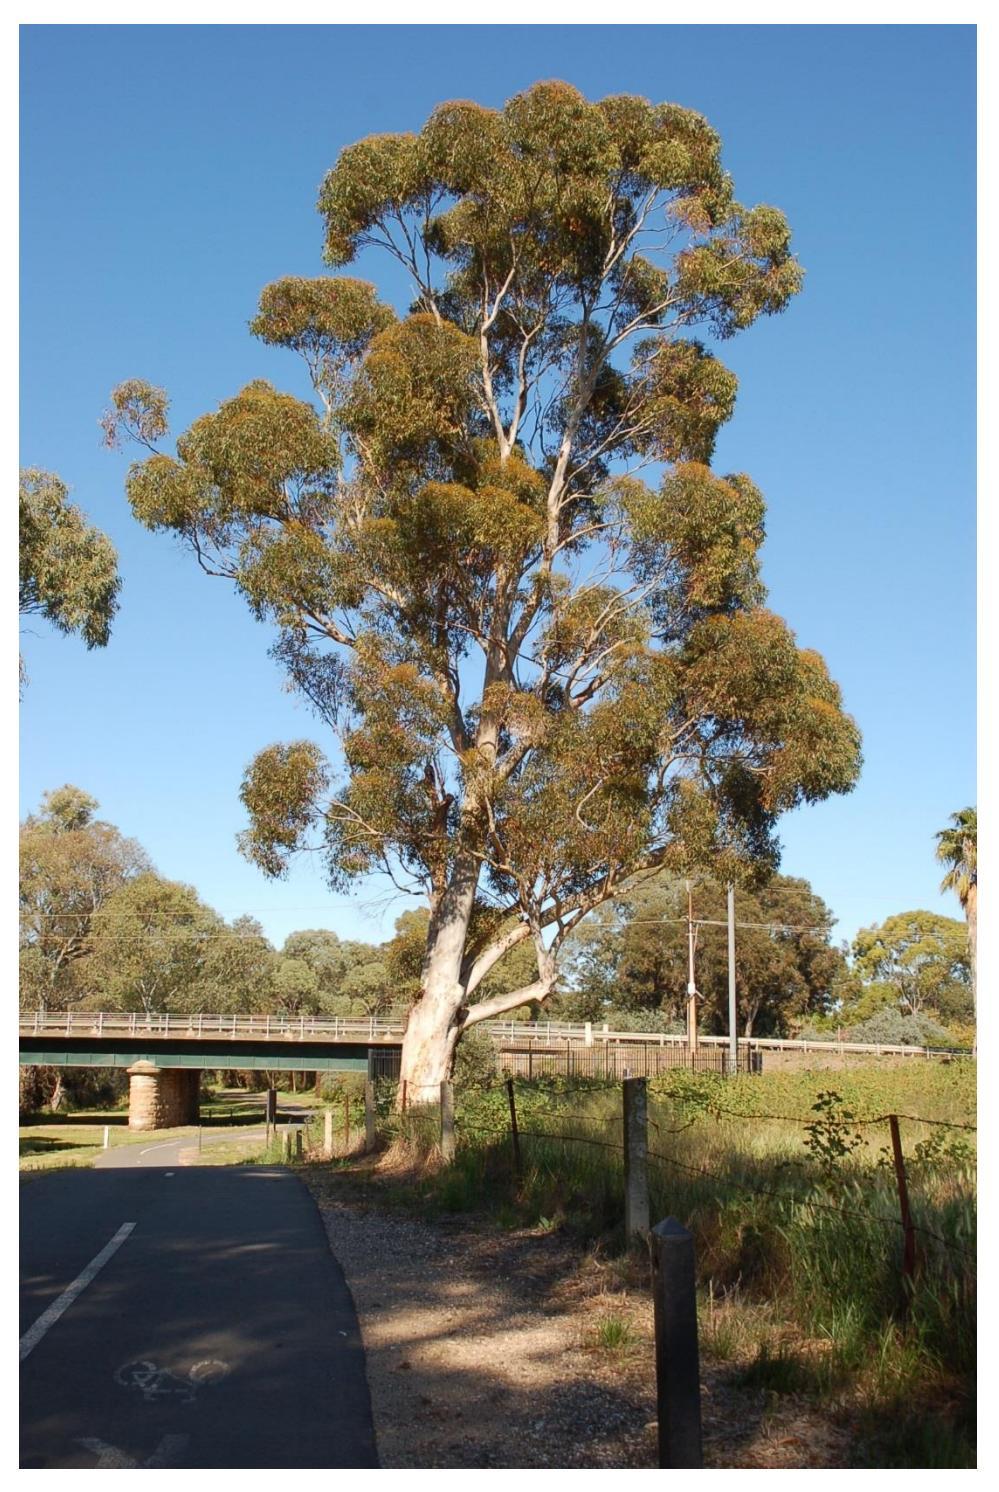
Chainage	Photos	Comments / Vegetation Issues	Potential Impact on Important Vegetation
0-200	2,3	Mostly through private properties with planted vegetation	Low
210	1	significant tree	High
220 - 270		No vegetation issues	Low

Photo 1 wpt 28 ch 210 E. cam., 1.2m diam., 20 X 13m, Significant, right on top of bank. Move centreline of bank at least far enough so that trunk is not buried. TPZ 14m radius

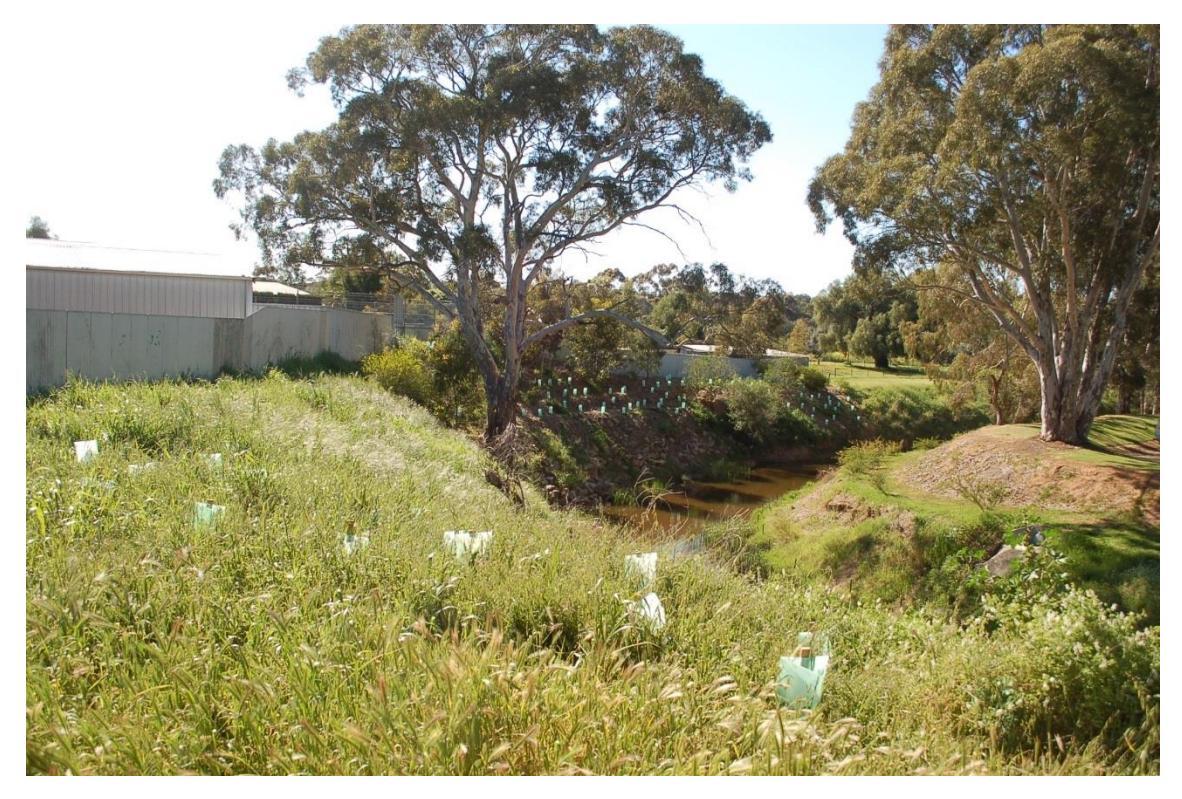
Photo 2 looking east from ch 160 along walled section – no vegetation issues

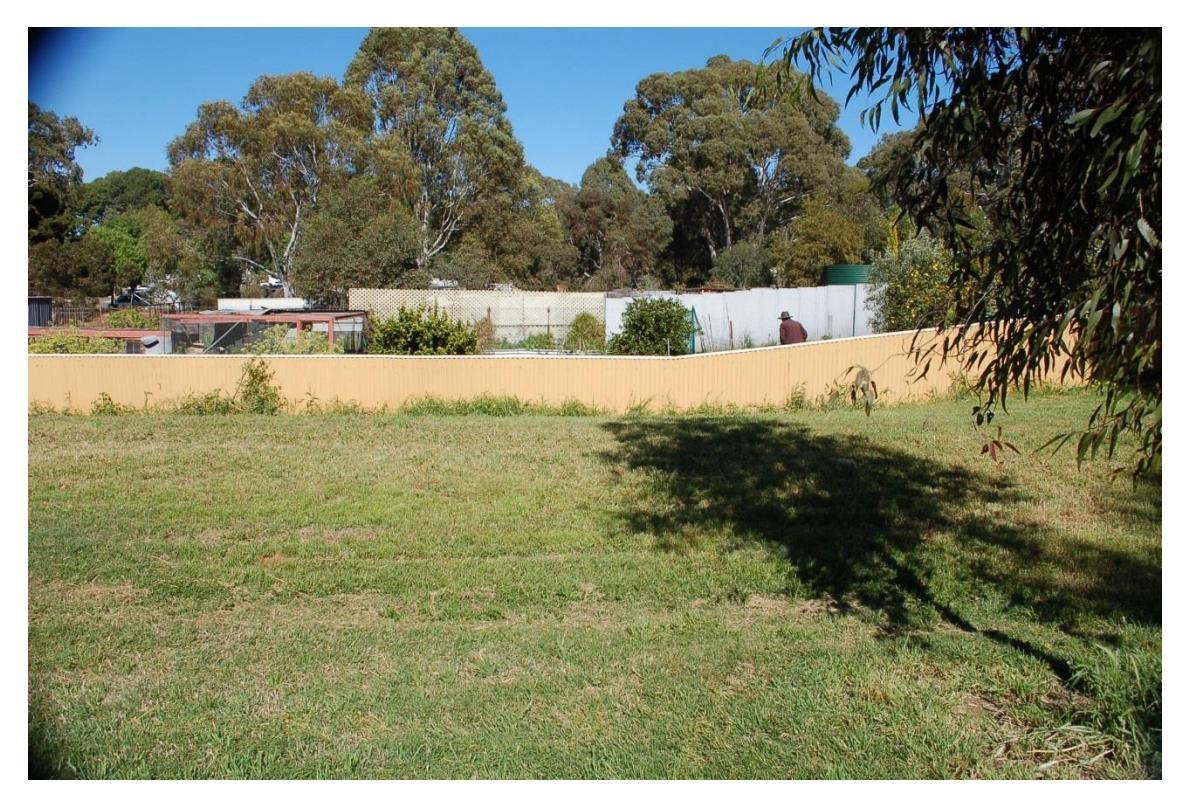
Photo 3 looking west from wpt 29 ch 30 – walled section crosses private property. Garden vegetation, no native vegetation issues

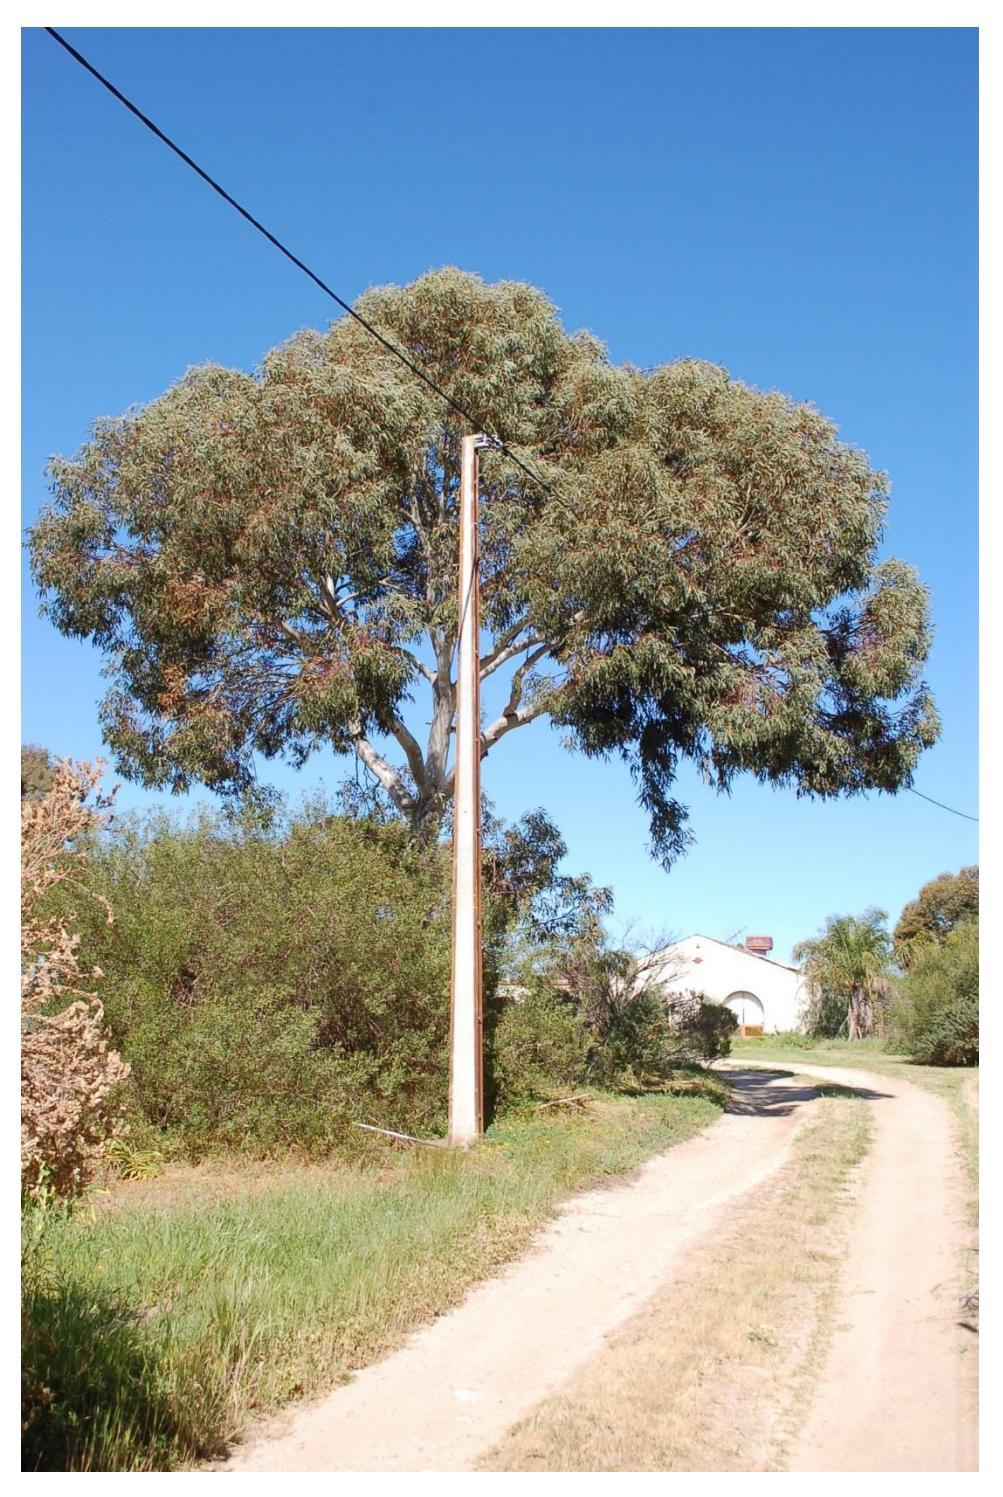
Photo 4 looking southwest to E. leucoxylon. at wpt 30 ch 420 on centreline of bank. Planted non-native, not Regulated size, 0.5m diam. 12m X 12m healthy. TPZ 6m radius

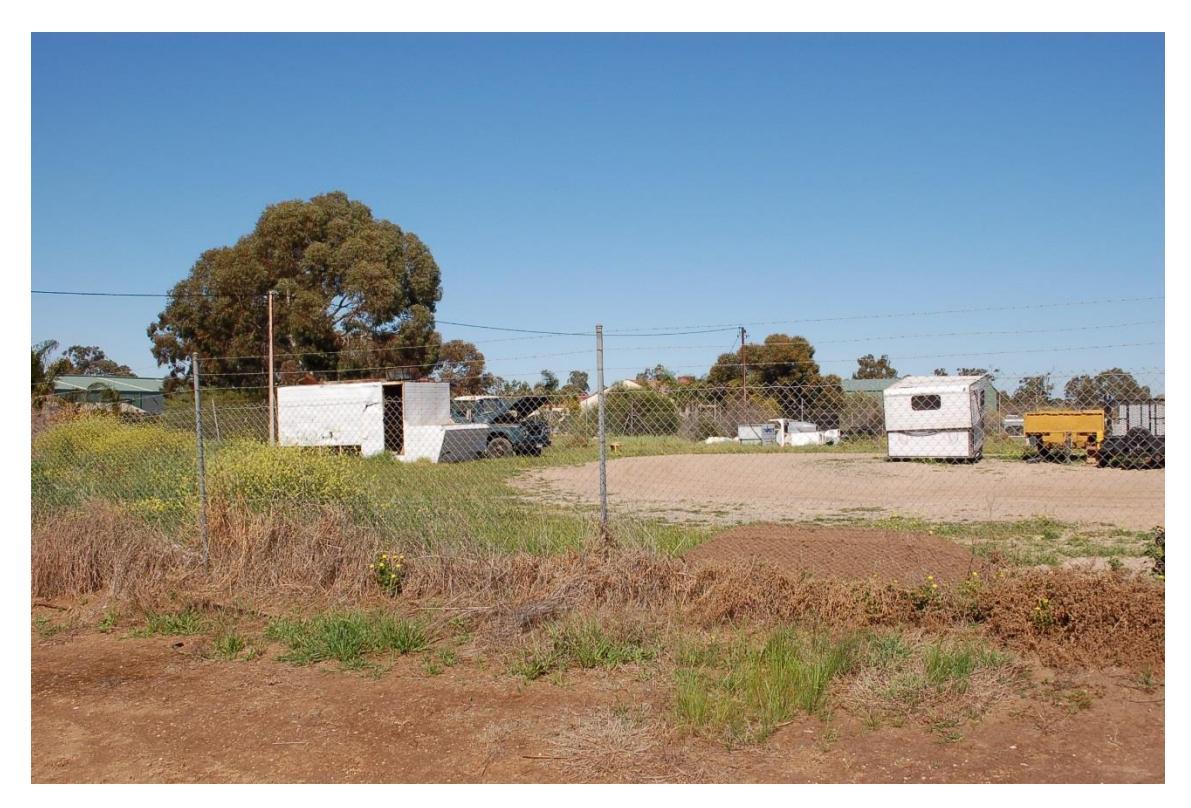
Photo 5 looking west from wpt 31 ch 360 – no vegetation issues

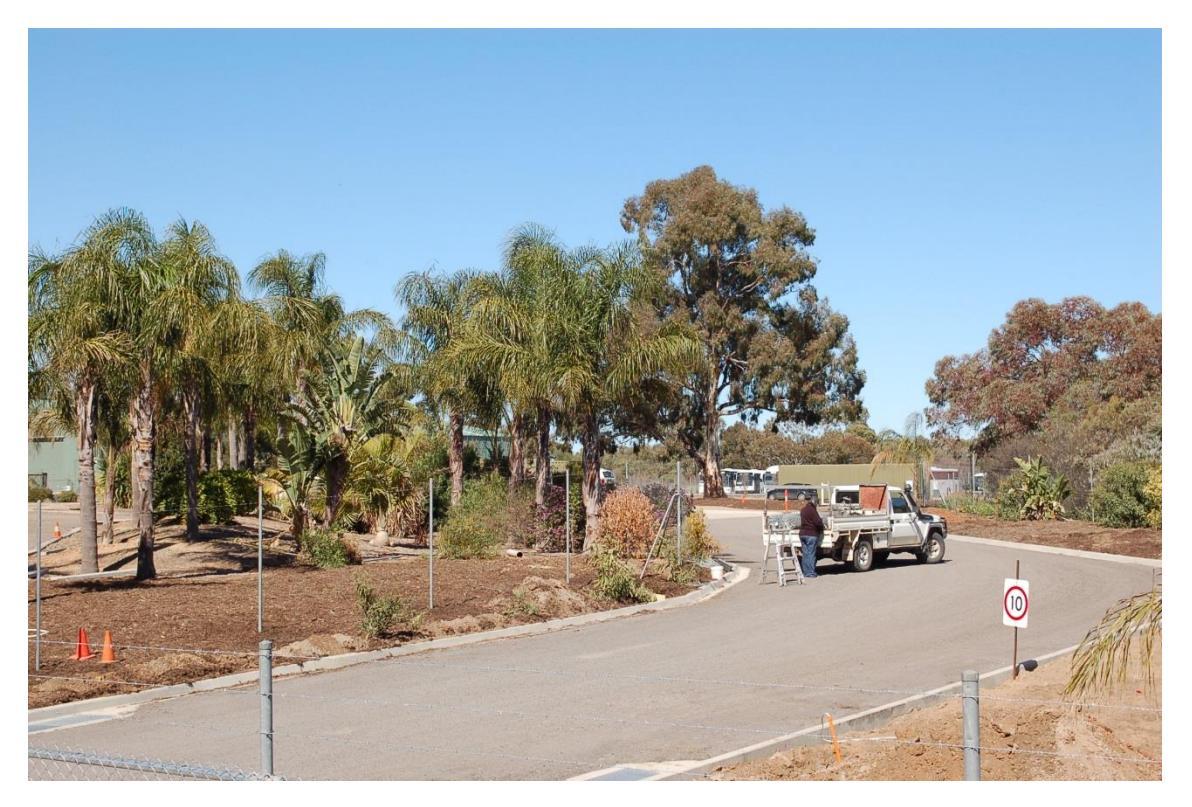
Photo 6 looking west from gate at end of Kelly Road – alignment passes through a private landscaped area with palms and lower shrubs. Garden plantings, no native vegetation issues

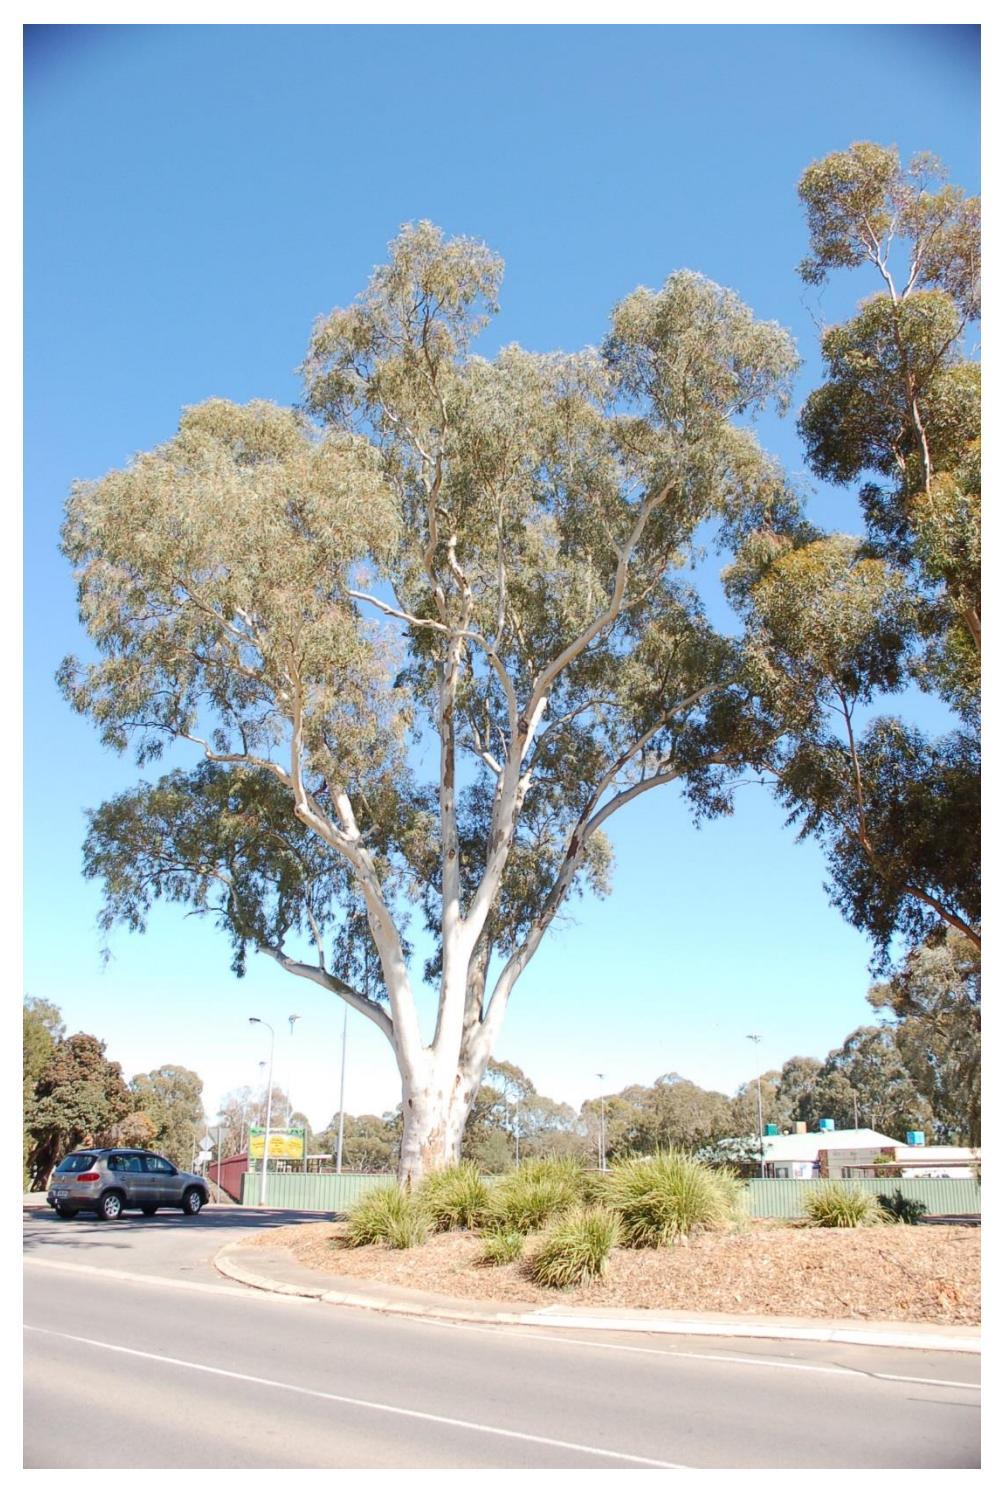
Photo 7 looking west to tree at wpt 32 ch 1160, walled section. Right on bank centreline. E camaldulensis. 1.5m diam. Significant tree 23m X 20m. TPZ 15m radius. Move wall alignment

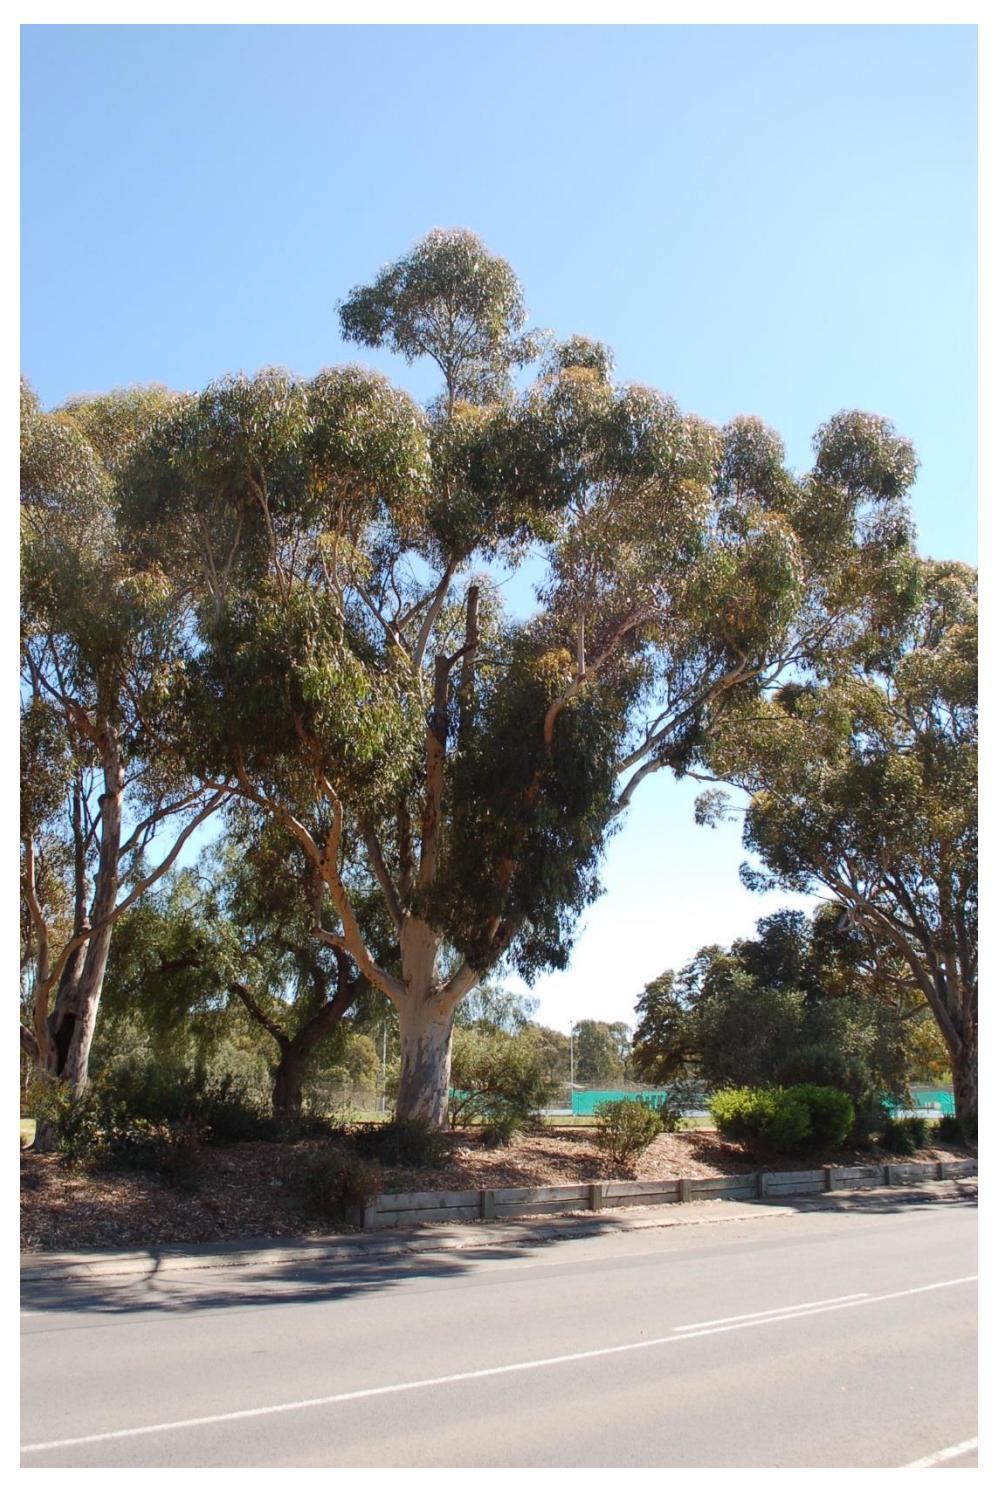
Photo 8 looking north to tree at wpt 33 ch 1120. Close to bank centreline. E cladocalyx. 0.95m diam. Significant tree 20m X 24m. TPZ 11.5m radius. Move bank alignment and/or use wall instead.

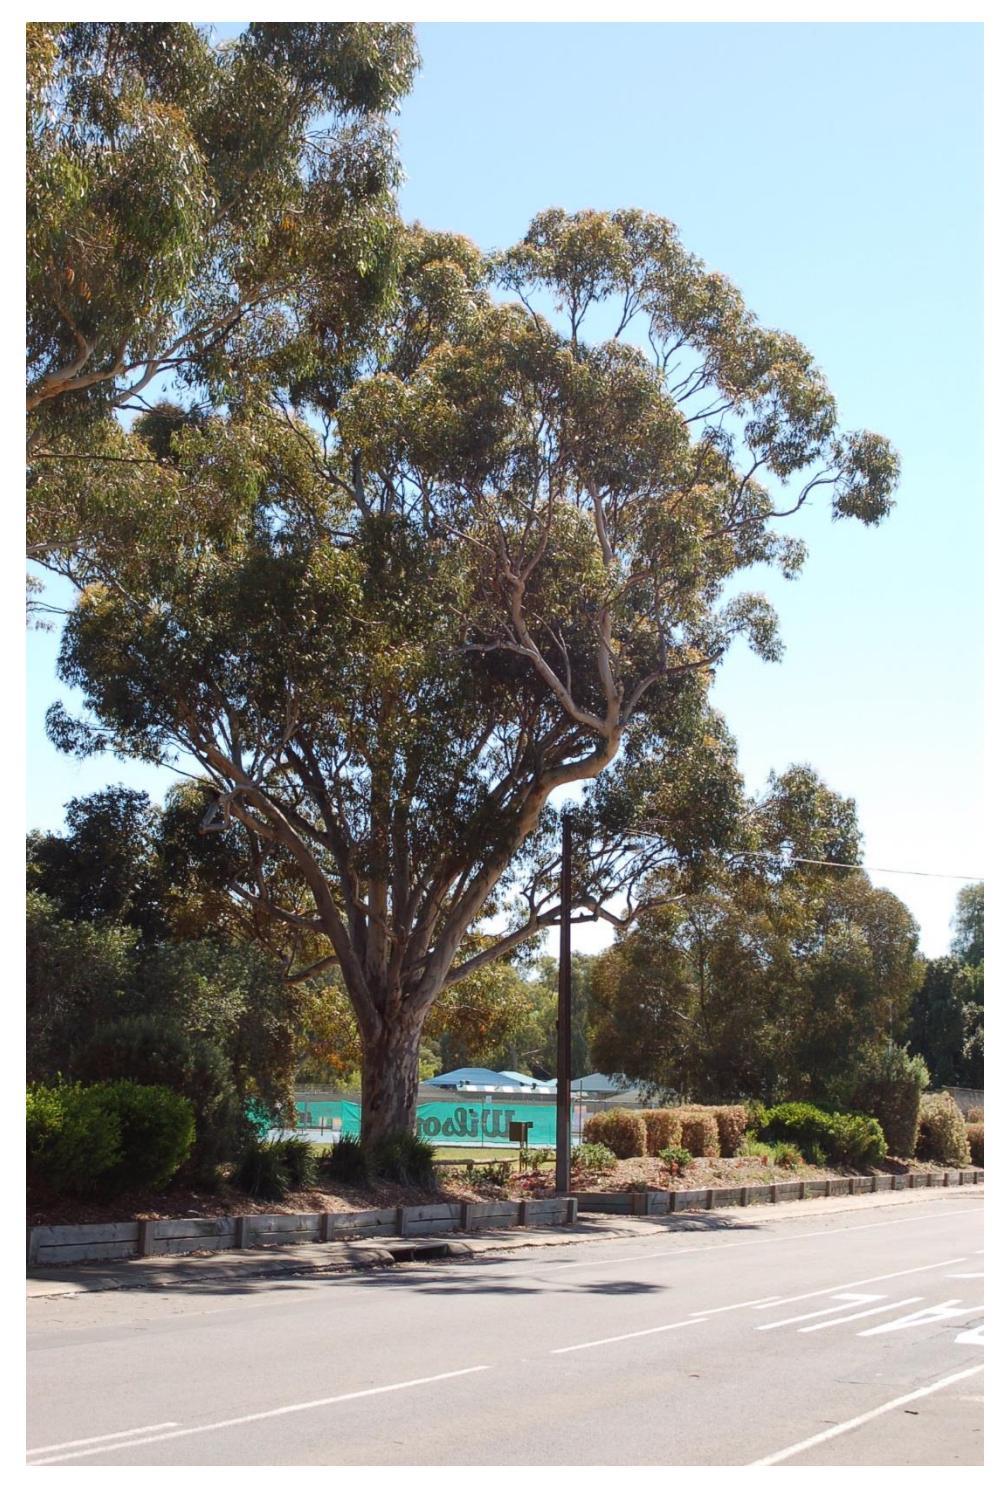
Photo 9 looking north to tree at wpt 34 ch 1105. Close to bank centreline. E cladocalyx. 1.05m diam. Significant tree 20m X 22m. TPZ 12.56 radius. Move bank alignment and/or use wall instead.

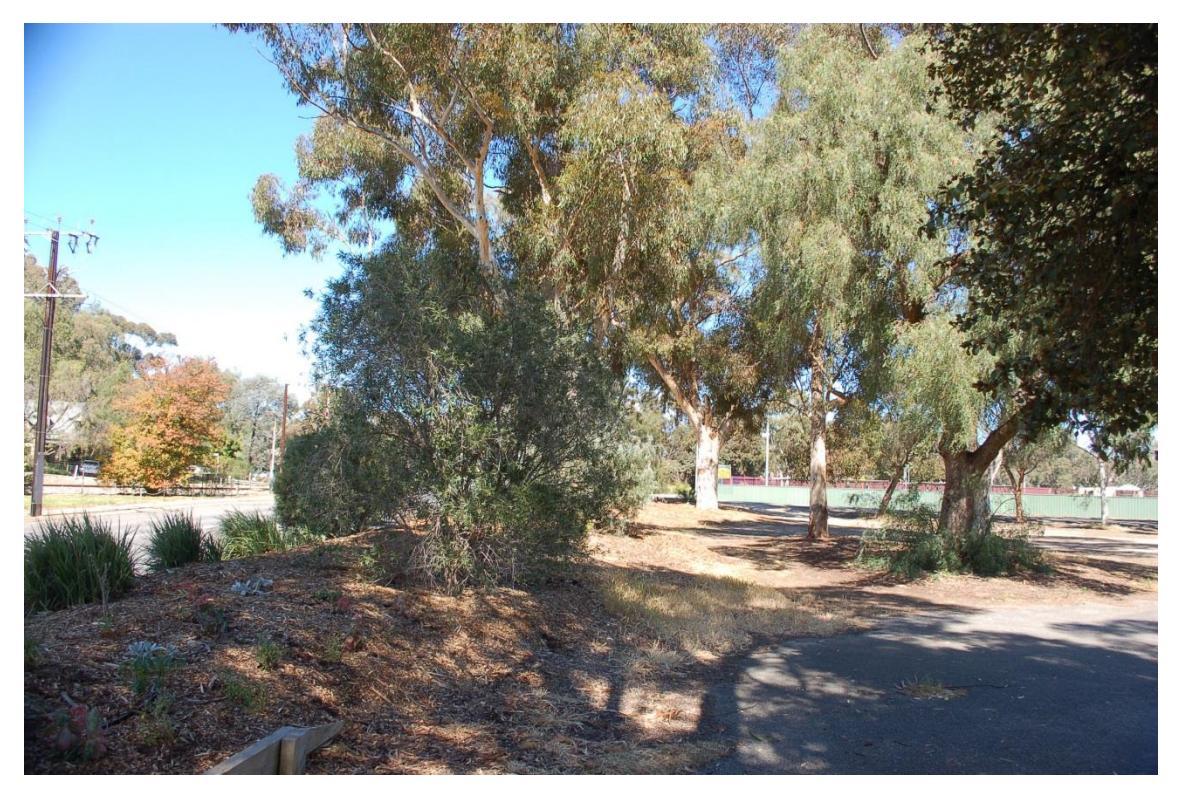
Photo 10 looking southwest along bank centreline – scope for moving to open area a few metres west to avoid trees

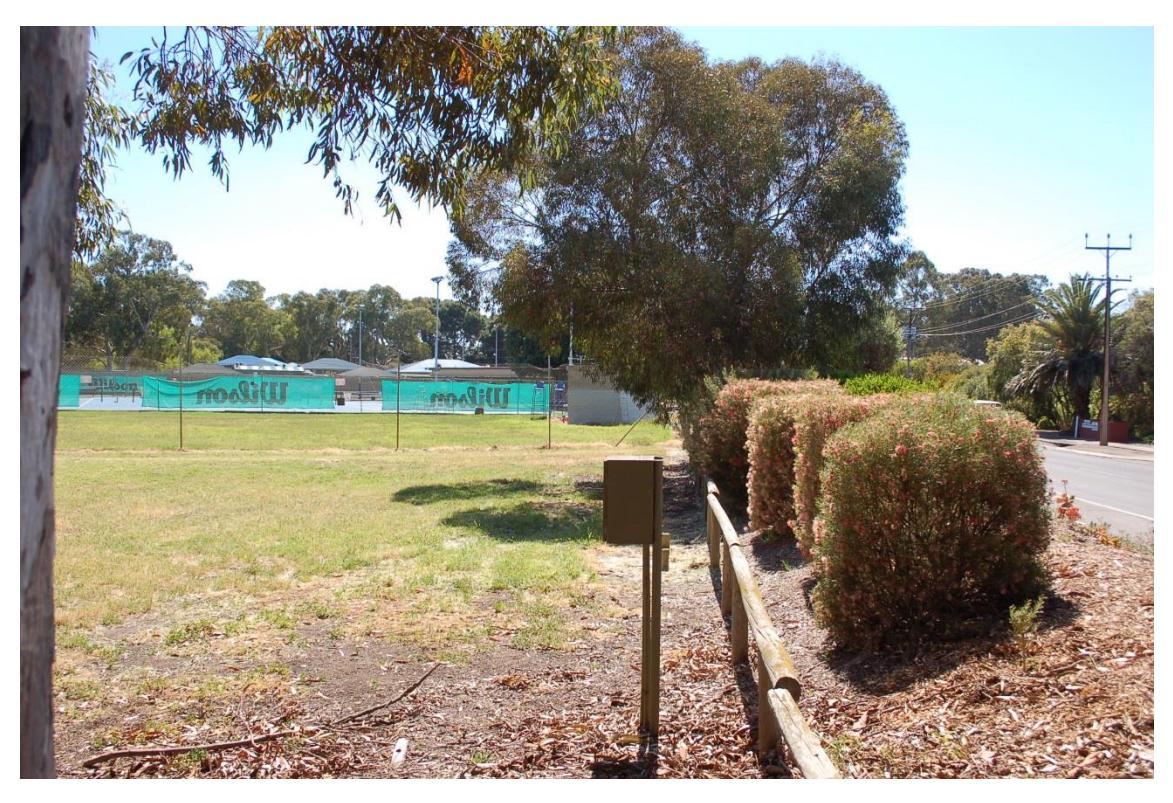
Photo 11 looking northeast along bank centreline – landscaping with shrubs

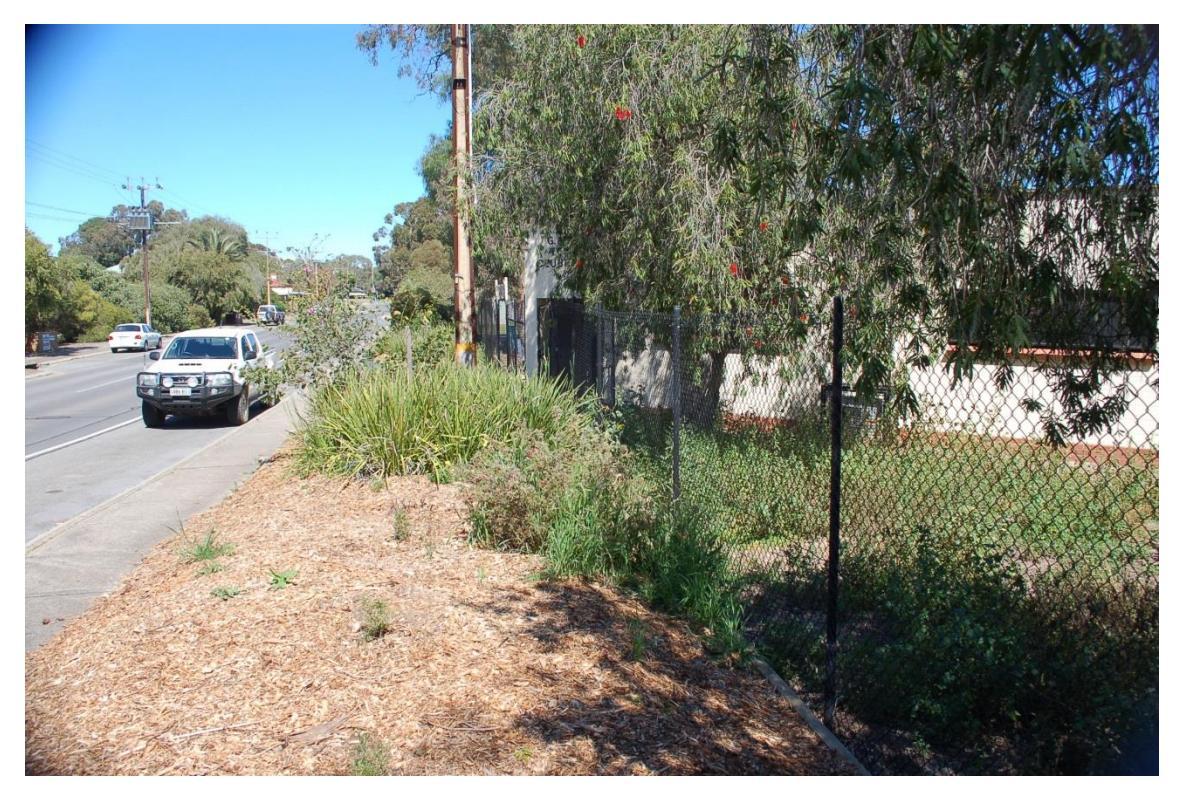
Photo 12 looking southwest along alignment from wpt 35 ch 1230, start of walled section – landscaping with shrubs

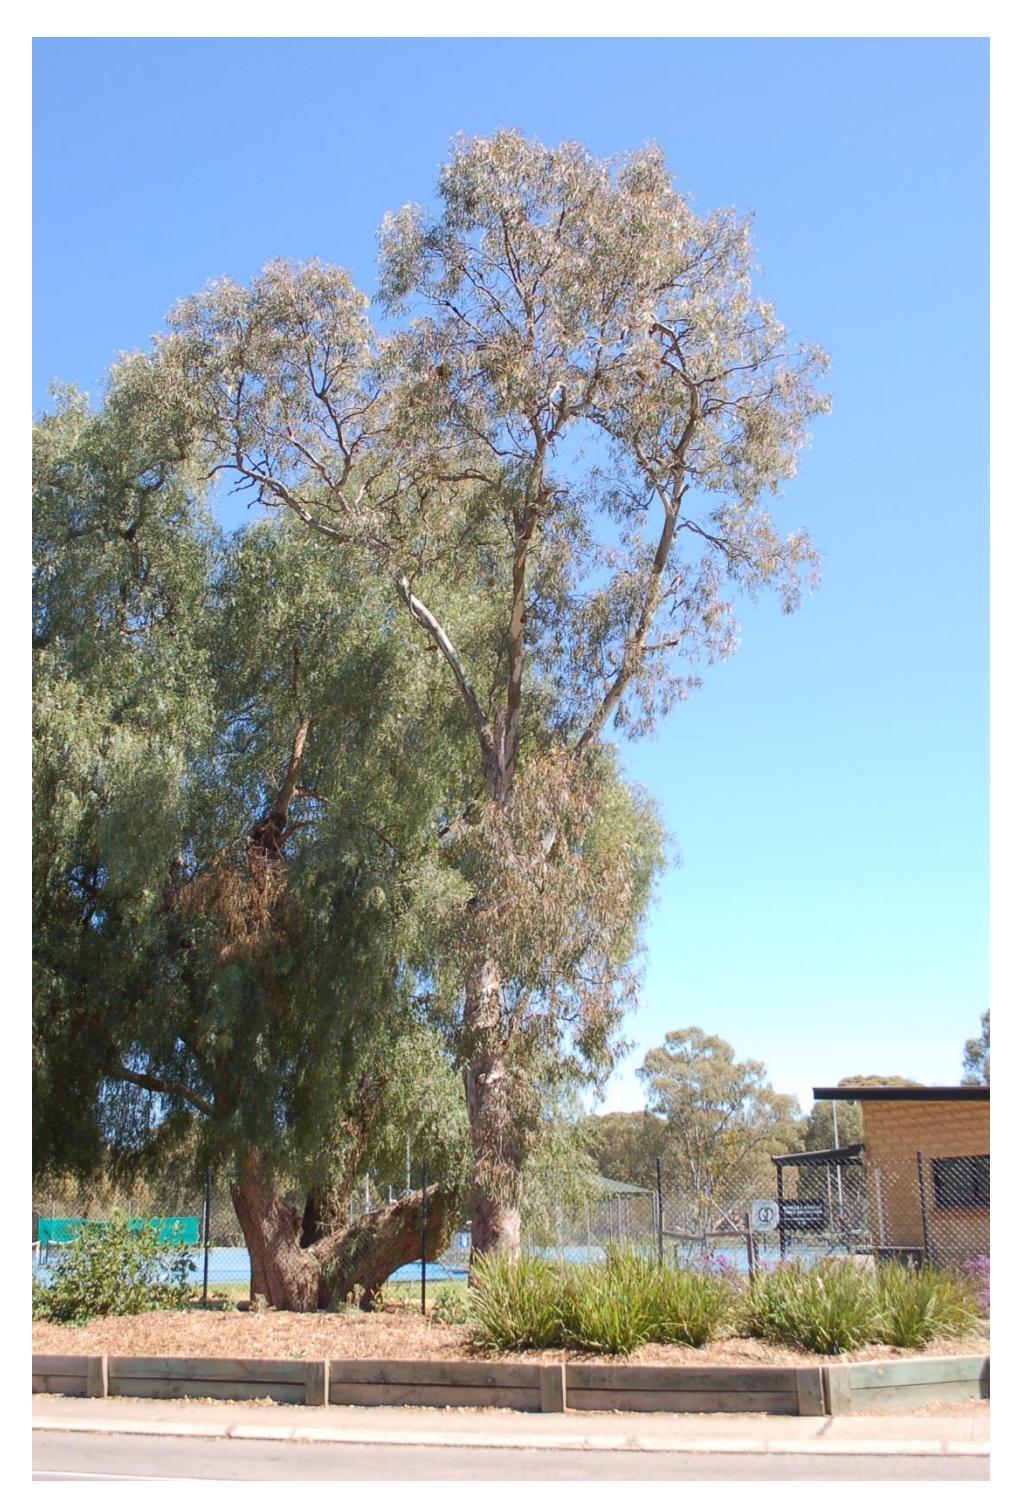
1180 - 1210	13	Continue walled section or move alignment closer to footpath to avoid burying base of regulated tree at ch. 1200	
1210 - 1240	12	Along existing embankment with low planted landscaping shrubs. No tree impacts	Low

Photo 13 looking west to tree at wpt 36 ch 1200 – E. camaldulensis 1-2m west of bank centreline. Minor burying (0.5m deep) at base. Poor health, Regulated size 0.8m diam. 18m X 12m. Continue walled section or realign closer to footpath

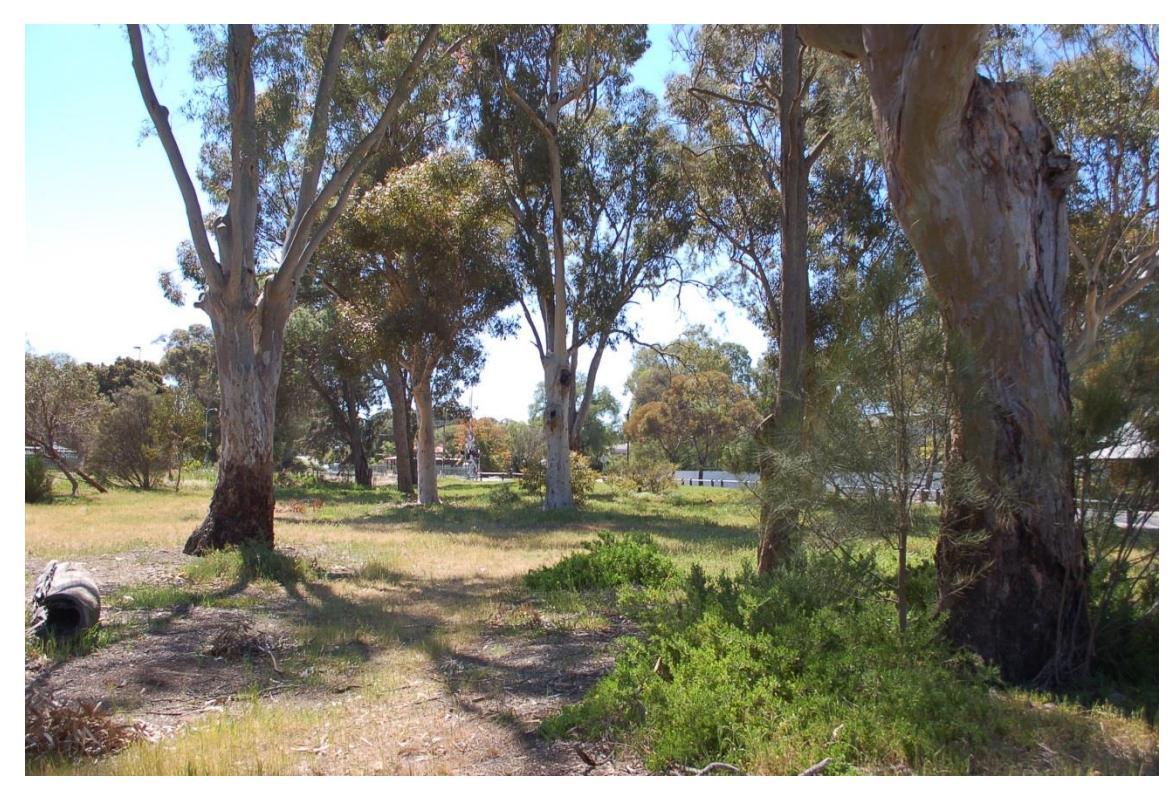
Photo 14 looking northeast from wpt 37 ch 900, end of walled section – negotiate between trees

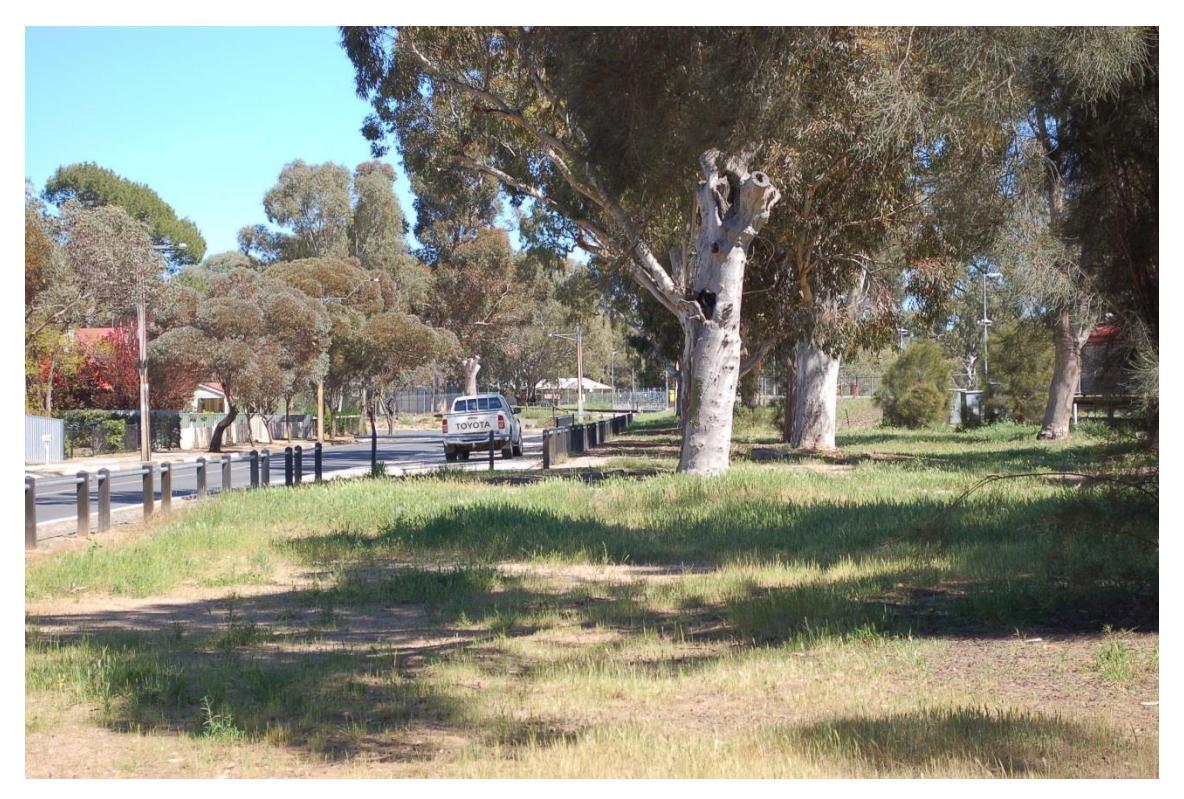
Photo 15 looking west from wpt 37 ch 900, end of walled section – bank centreline very close to front line of planted row of E. leucox. along parking area. All Significant trees. Will bury bases, and be well within TPZ of all these trees. Move south to edge of car park and/or use wall instead of bank

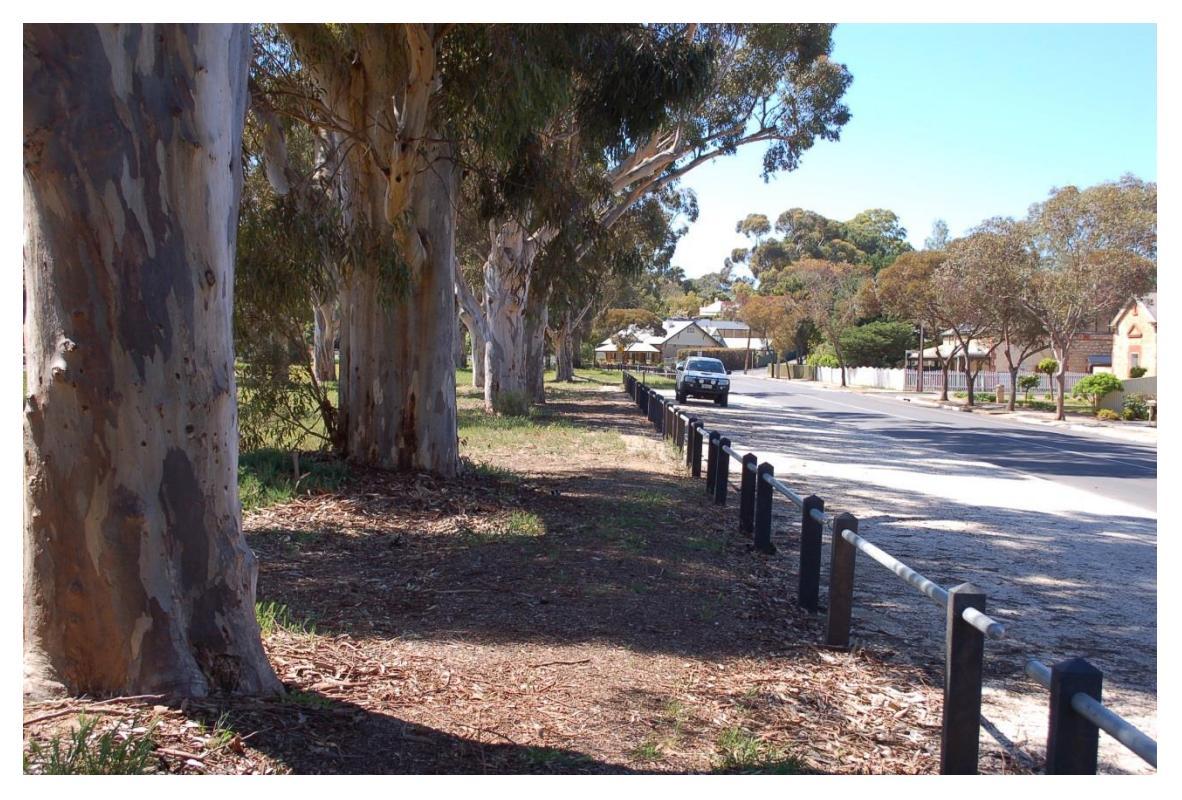
Photo 16 looking east from wpt 38 ch 780, end of walled section – bank centreline very close to front line of planted row of E. leucoxylon. along parking area. Will bury bases, and be well within TPZ of all these trees (approx.. 12m radius). Move south to edge of car park and/or use wall instead of bank

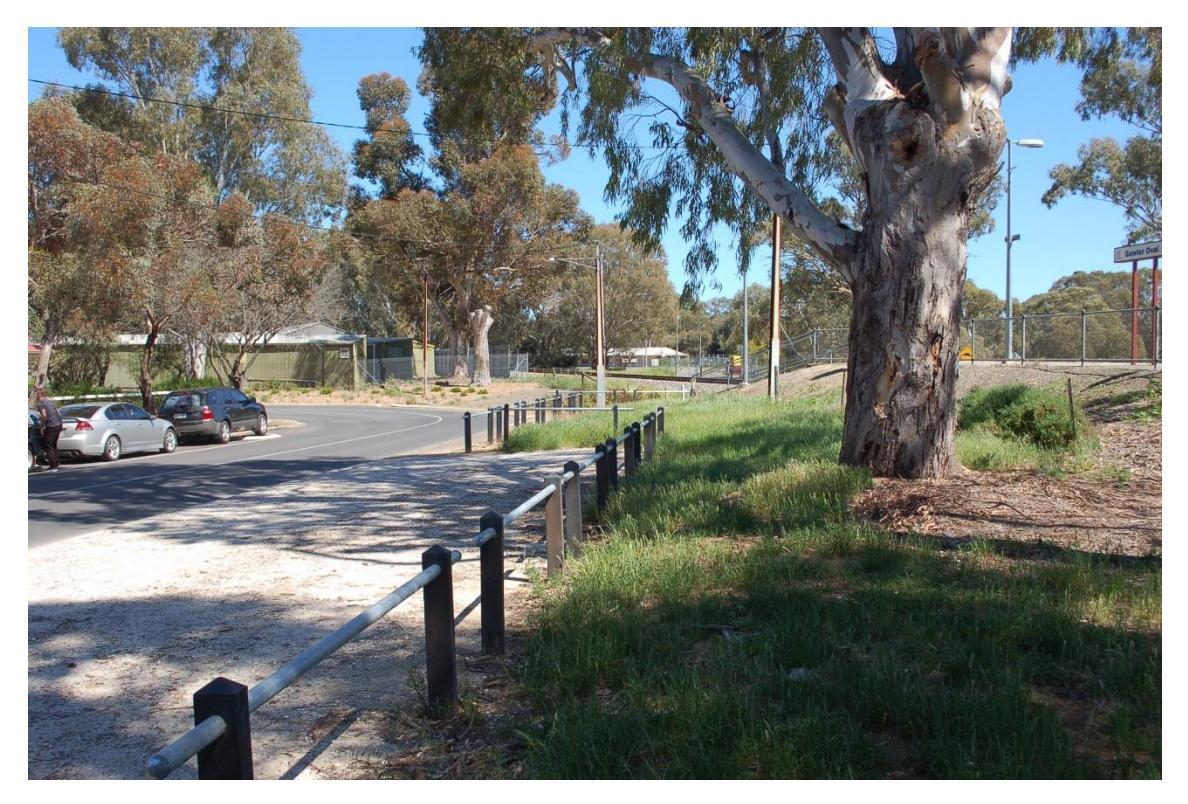
Photo 17 Looking west from start of walled section – deviate south to be outside TPZ of E. leucoxylon. Significant tree. TPZ 13m.

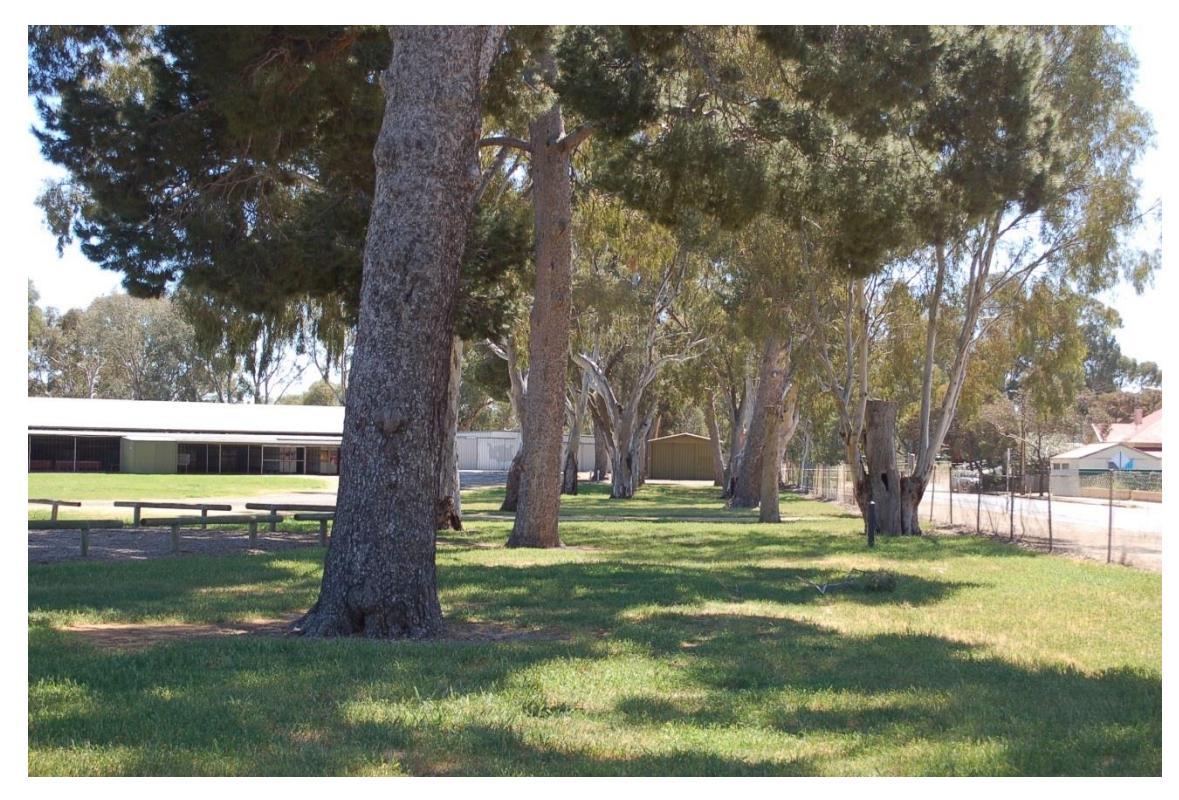
Photo 18 looking north along bank centreline from wpt 39 ch 550 (start of walled section) – move alignment 15m west to avoid all trees

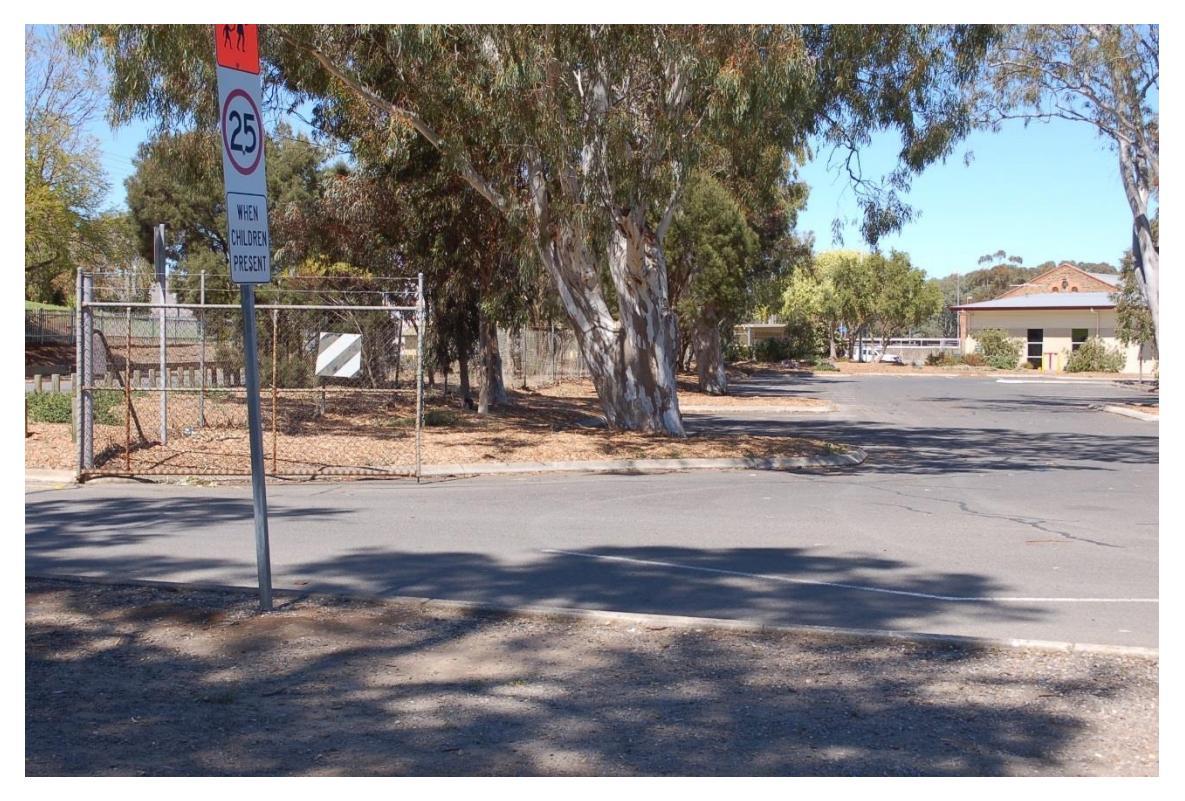
Photo 19 looking south along wall centreline from wpt 39 ch 550 (start of walled section) – move alignment 10m east along footpath to avoid all trees

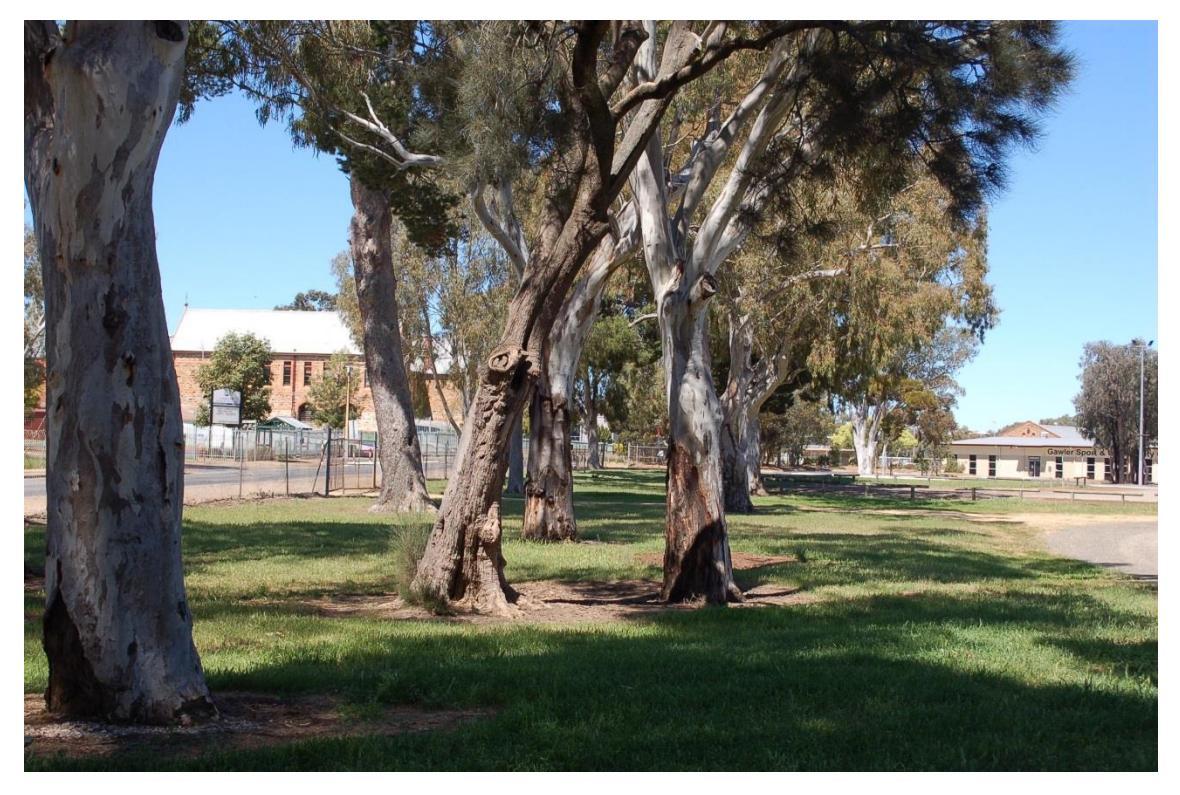
Photo 20 looking south from wpt 40 ch 660 (start of bank section) – move alignment 15m west to avoid all trees
