Levee Bank Discussion Paper

Town of Gawler

May 2018

Gawler Stormwater Management Study

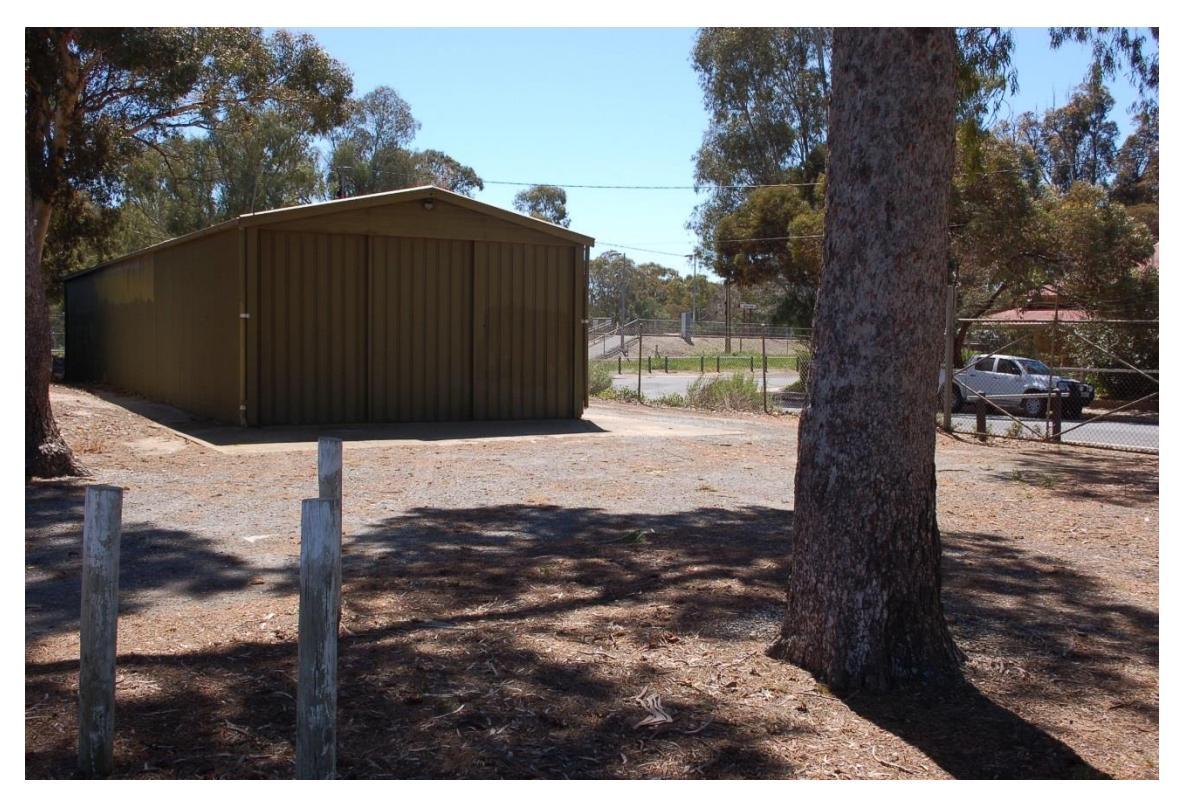
Photo 21 looking northeast from wpt 40 ch 660 (end of walled section) – move slightly west to avoid larger trees
