TOWN OF GAWLER

HISTORIC WALLS IN THE PUBLIC ENVIRONMENT, GAWLER, SA CONSERVATION STRATEGY

September 2007

McDougall & Vines, Conservation and Heritage Consultants
27 Sydenham Road, Norwood, South Australia 5067
Ph (08) 8362 6399 Fax (08) 8363 0121
Email: mcdvines@bigpond.com

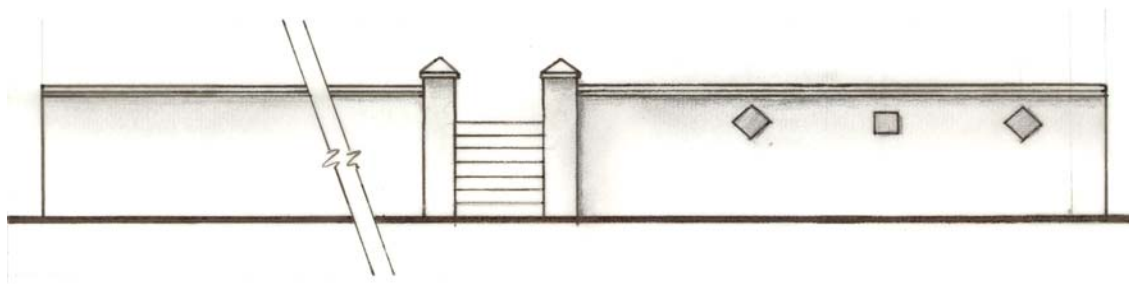
Scale 1:100 – note full slope of wall not shown

Length of wall – 42 m **Height of wall** – 1820 - 2100 (varies with the slope of the wall – slope not shown) **Gate piers** – 500 x 500 Cant brick along the top. (later steel strengthening plates shown)

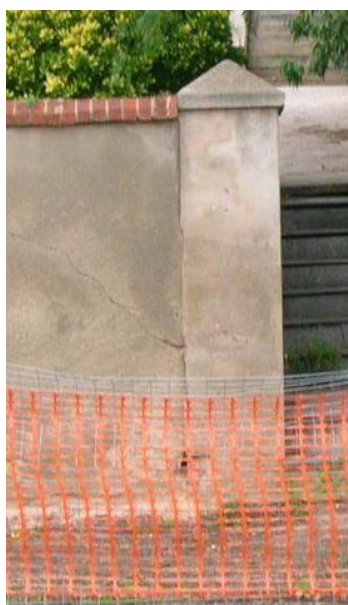
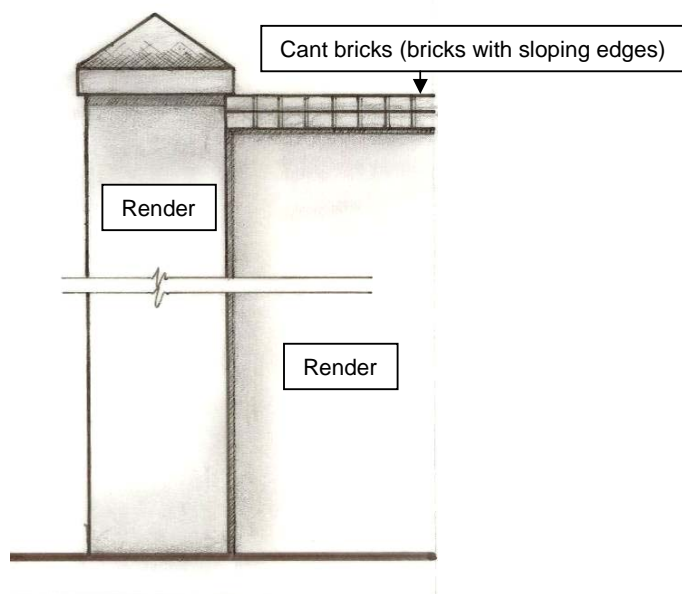
Scale 1:20

Pier details (pier size 500 x 500 x approx 2100 high - varies)

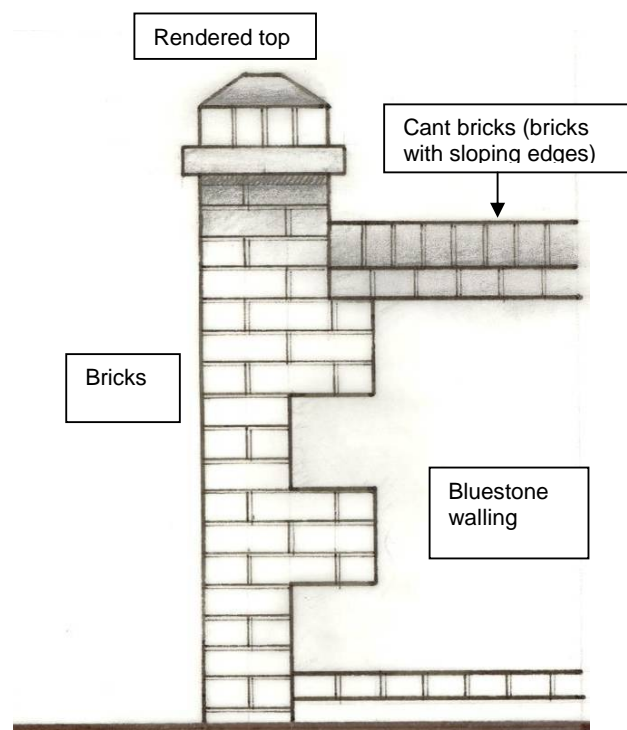
Scale 1:20

Pier details (pier size 350 x 350 x 1830 high)

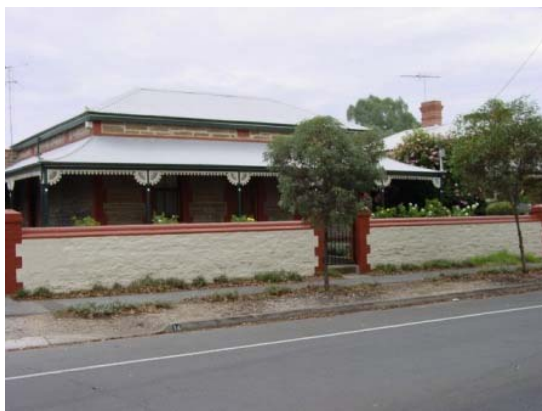
14 Fourteenth Street, Gawler South

Description: These walls all have straight tops and are all in good condition. All the face stone has been painted. They are an excellent group of fences of a similar design.

- Removal of paint from stonework - paint removal from stone is undertaken using paint removal chemicals and hot water applied at low pressure. This is undertaken by specialist contractors, and all the chemicals and removed paints have to be removed away from the site. (refer Section 5.6 for details)
- Assessment of condition of stone underneath removed paint - once paint has been removed it is possible to check the condition of the stone underneath the paint. It will then be possible to determine if stone replacement is required and how much re-pointing will need to be undertaken. Replacement of stone should be undertaken as required and any re-pointing of stone and brickwork undertaken.
- If damp proofing of any of the walls is required refer to Section 5.2 for methodology for damp proofing of walls.

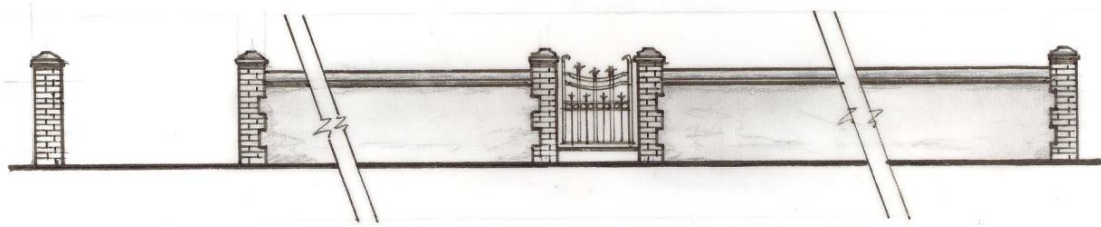
Scale 1:100

Length of wall – 7 m on either side of the gate **Height of wall** – 1380 **Gate piers** – 350 x 350
 Cant brick (brick with sloping edge) and rendered bevelled edge along the top.

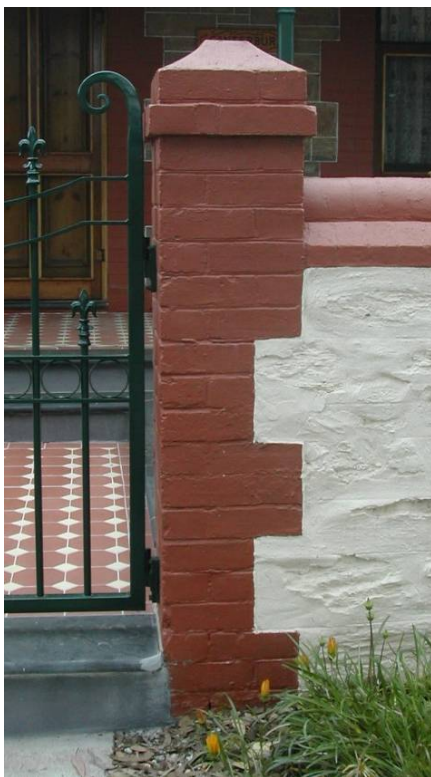
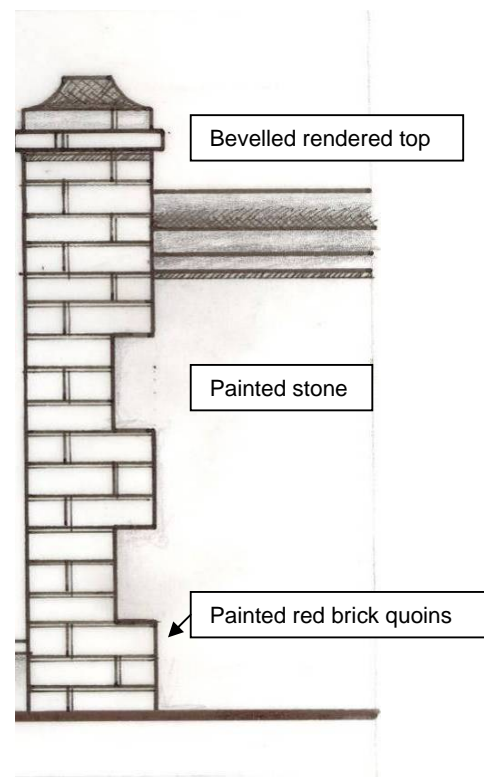
Scale 1:20

Pier details (pier size 350 x 350 x 1780 high)

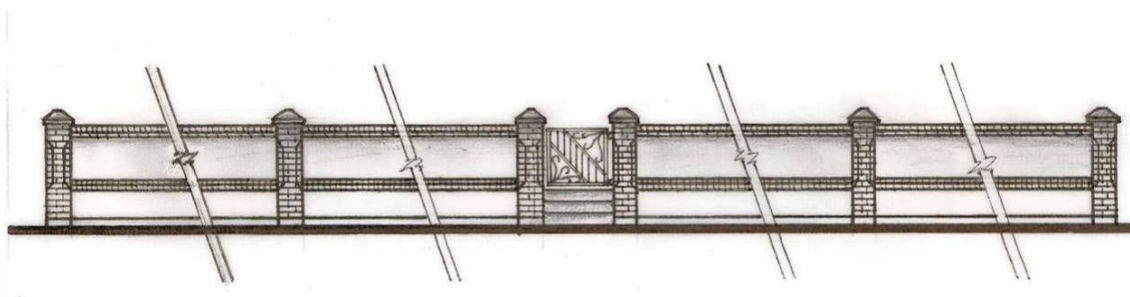
Scale 1:100

Length of wall – 9 m on the left side of gate, 10.5 m on the right side of gate **Height of wall** – 1405
Gate piers – 350 x 350 Brick along the top.

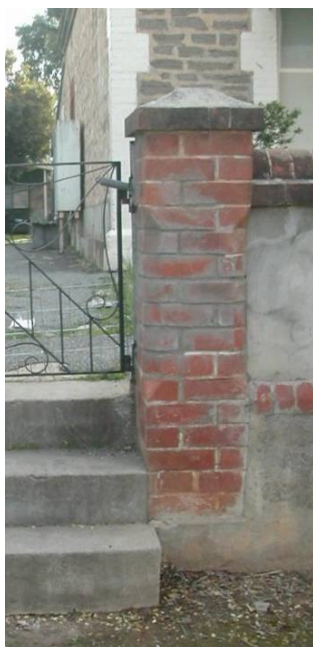
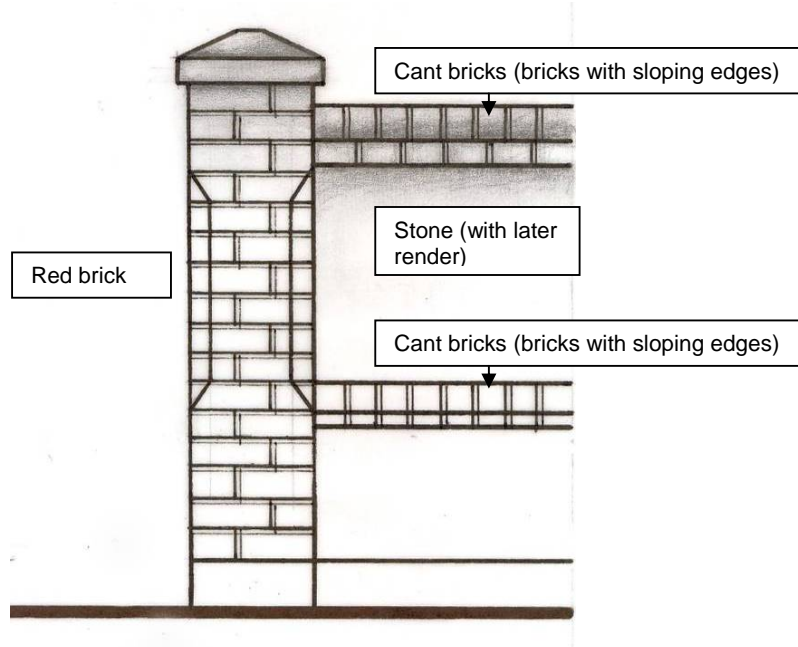
Scale 1:20

Pier details (pier size 350 x 350 x 1595 high)

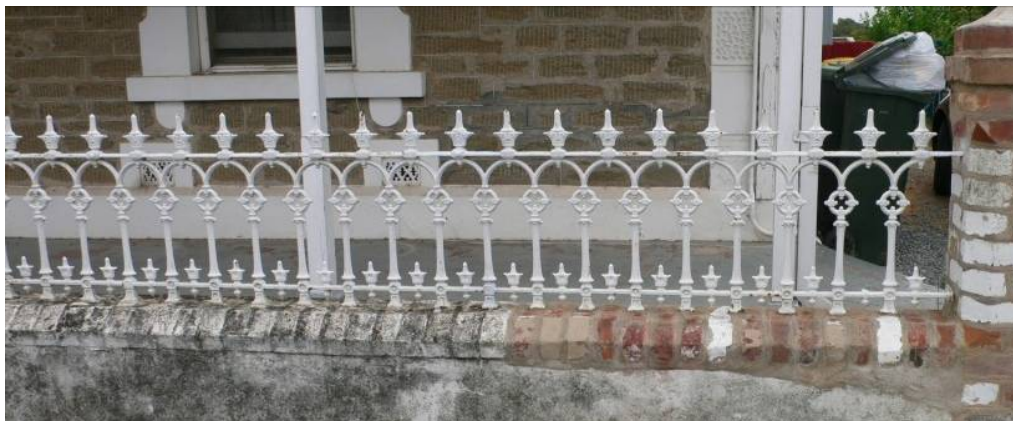
DRAWINGS OF WALL (32 Fourteenth Street, Gawler South) – note this wall has had the top spikes of the iron removed. The iron pattern would have been same as 15 Queen Street below

15 Queen Street railing – this fence matches that at 32 Fourteenth Street with balustrade pattern originally containing the spikes on the top.

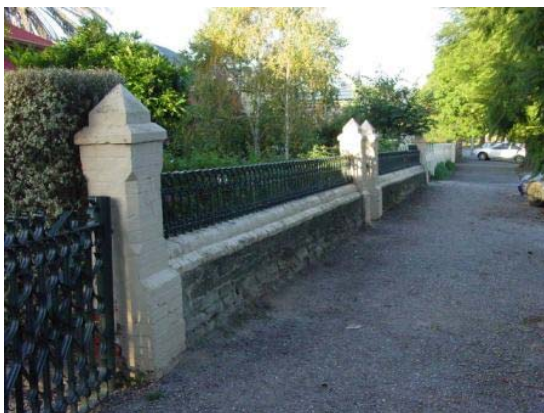
55 Cowan Street, Gawler

Description: Both these walls have rising damp, evidenced by the missing mortar (and later cement re-pointing) at 55 Cowan Street, and the later brick joint lines to the fence at 18 Cowan Street. Both walls are otherwise in good condition.

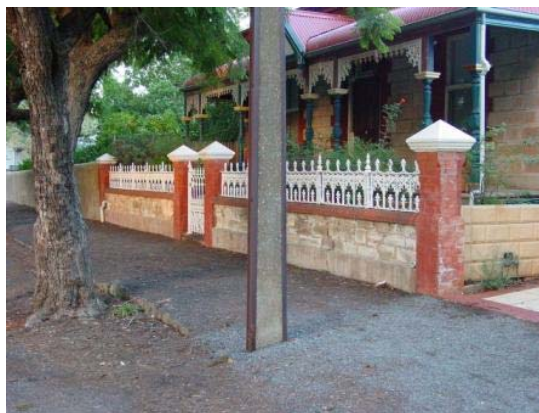
18 Cowan Street, Gawler

18 Cowan Street: a sandstone wall in good condition, which is acting as a retaining wall to the front garden. The wall shows evidence of later re-pointing and repairs with later joint lines. The fence incorporates tall brick piers with some brick deterioration evidence. There are also hard cement repairs. The wall sits on a rendered base course which shows signs of cracking. There is evidence of surface salts and efflorescence.

- Plastic repairs - the brick surface which is flaking could be repaired with brick dust plastic repairs which act as a veneer to prevent further deterioration. Refer Section 5.8 for details on this. Remove previous hard cement repairs.

- Base course of wall - some mortar repairs should be undertaken using 3 parts sand to 1 part cement at the base, and the base finished in a brick red colour to match the original. painted in a cementitious paint.

- Sandstone within the wall the wall face - these stones could also be repaired using plastic repairs (refer Section 5.8 for details) using ground stone, sand and lime mix.

- Rectify stormwater drainage in south west corner which runs down the face of the wall causing deterioration. This drain should be re-routed to the street so that the drains are clear of the wall and the pier.

- Treatment of surface salts on the brickwork should be in accordance with recommendations outlined in Section 5.7.

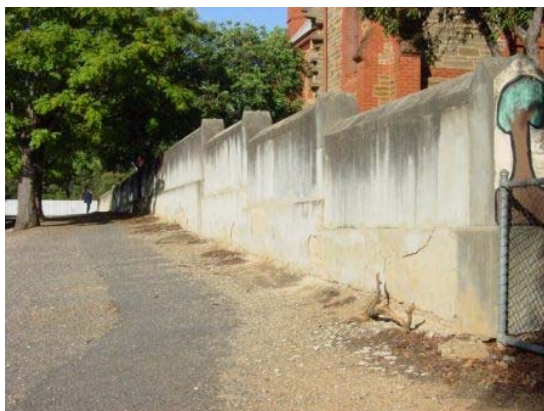
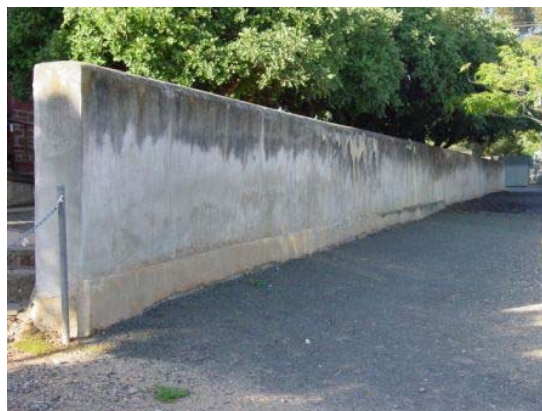
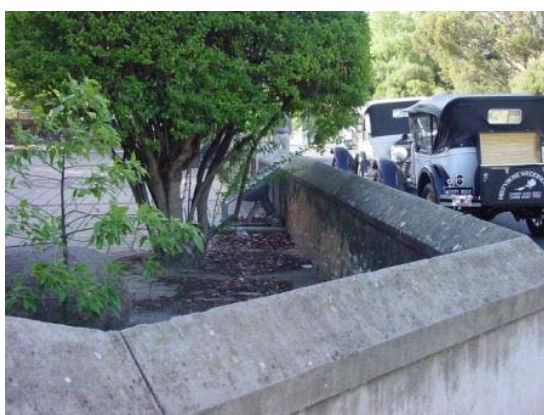
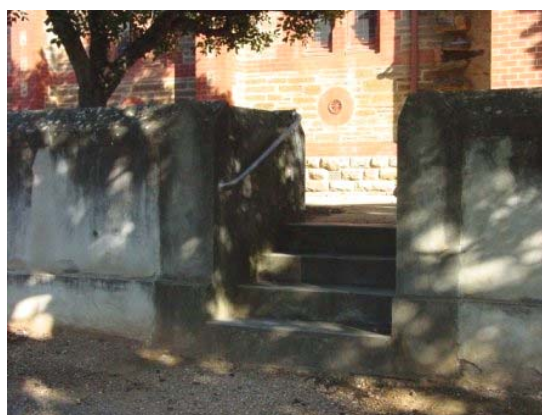
Description: This is a stone wall with three perimeter sides around the Church property. It is a stepped wall with a plinth and rendered piers. The wall was originally face stone as can be seen on the 1909 early photo of the church. The render is in good condition, and the most practical approach for this fence is to retain the rendered finish. However, the rendered wall face could be cleaned, and this should be undertaken with careful washing using biocides to remove mould and dirt accumulation. The inside of the wall is deteriorated in particular in the south east corner, and requires render repairs to be undertaken.

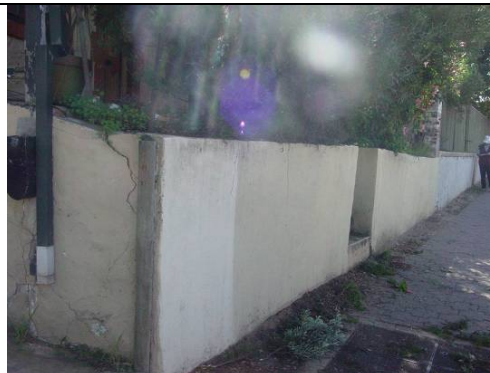
Street	Property No	Wall No	Field Map ID	Wall Height (mm)	Wall Length (metres)	Retaining Wall (Y or N)	Htg. Status	Hist. Cons. Zone/Area	Special Features	Additional Comments	Priority Ranking	Photo ID
										Queen St		
High	17	183	3	1200	20	N	Contr	GEHCPA	Gate, rendered end columns, arched brick capping		4	207
High	25	222	5	2000	40	Y	Local	HCZ	Rendered, angled brick capping, slate stepped entranceway	In repair	1	252, 254
High	25	223	5	1800	40+	Y partly	Local	HCZ	Stepped uphill		2	253
High	35	224	1	2000	35	Y	-	HCZ	Gate, slate steps, brick end columns & angled brick capping	Part rendered	4	255
Hillier	27	257	7	1500	15	N	-	-	Rounded top, rendered	Middle section iron sheeting. Wall at both ends.	2	291
Hillier	60	258	7	600	30	N	-	-	Rendered brick with columns and top rail	Age?	3	293
Hillier	60-62?	257	7	600	15	N	-	-	Stone wall, brick columns	Side wall	1	292
Howard	13	153	4	1100	10	N	Contr	LHCPA	Brick rendered		1	177

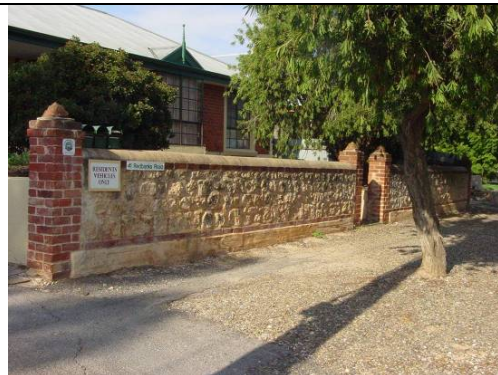
Redbanks Rd	41	168	3	1200	20	Y partly	Contr	WRHCPA	Gate, brick columns & rounded brick capping		2	192
Redbanks Rd	47	167	3	600	12	Y	Contr	WRHCPA	Rendered	Painted	1	191
Redbanks Rd	51	166	3	600	12	Y partly	Contr	WRHCPA	Stone base, brick & hedge upper	Base only	1	190
Redbanks Rd	55	165	3	600	10	Y partly	Contr	WRHCPA	Rendered, column & iron picket on stone base	Base only Painted	2	189
Reid	4	97	2	1100	20	N	Local	LHCPA		New brick wall replaced old, adjacent Jacob St	4	114
Schiebener Tce	1	109a	5	2000	10	N	State	LHCPA	Rendered, step down, rounded brick capping	Rear wall, adjacent Tod St, end part of wall No 109b	1	129
Second	1	213	6	800/1600	18	N	Contr	GSHCPA	Angled brick capping, columns, contrast rendered, iron lattice upper, inset gate	Painted	1/4	222, 223
Second	8	286	7	1100	10	N	Contr	GSHCPA	Rounded top, brick columns, rendered	Painted	3	321
Second	13	287	7	1200	12	N	Contr	GSHCPA	block stone, rendered angled capping & columns		1	320

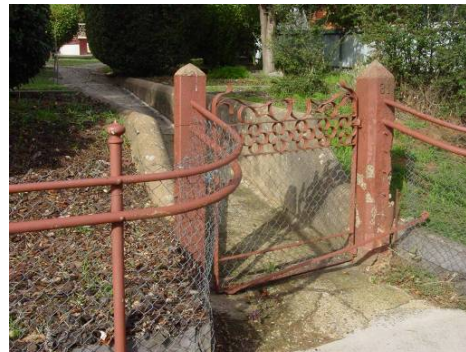
Blanch	31	189	1	300-800	6	Y	Contr	HCZ	Rounded top (Rendered or concrete?)	Sloped garden path retaining wall. Age?	4	214
Blanch	35	188	1	1000	10	Y in part	Contr	HCZ	Rendered, rounded capping	Painted, topped with new iron picket	4	213
Bridge St Sth	Bridge	315	5	1400	10	N	Contr	GSHCPA	Flat top, rendered	Painted, end section of bridge wall, mid section iron rail fence.	2	359
Brown	9	162	4	1000	25	N	-	-	Gateway		2	186
Brown	13	163	4	600	10	N	-	-	Remnant		1	187
Calton	1	261	5	3500	20	Y	State	GEHCPA	Brick capped, linear brick insert midway	Phoenix Foundry	4	296
Calton	6	204b	5	1200	16	N	Contr	GEHCPA	As wall No 204a, gateway		1	234
Calton	6	204c	5	1800	30+	Y in part	Contr	GEHCPA	Sloped downhill, patch rendered, round capped.	Side wall	2	235
Calton Rd	6	204a	5	1800	25	Y in part	Contr	GEHCPA	Stepped downhill, patch rendered, round capped, brick ends	Side wall, adjacent Daly St	1	233
Cameron	1	63	2	1200	16	N	State	LHCPA	Rendered, gateway	Painted	3	79
